To Jimmy Songvilay  
Kin Living  
139 SE Taylor Street, Suite 200  
Portland OR 97214

Revised March 14, 2022 by  
RDH Building Science Inc.  
5331 SW Macadam Avenue #314  
Portland OR 97239

RDH Building Science Inc. (RDH) was retained by Kin Living to undertake an assessment of the current condition of the building enclosure of the buildings at the Quintet Condominiums complex located at 6695 W. Burnside Road, Portland, OR.

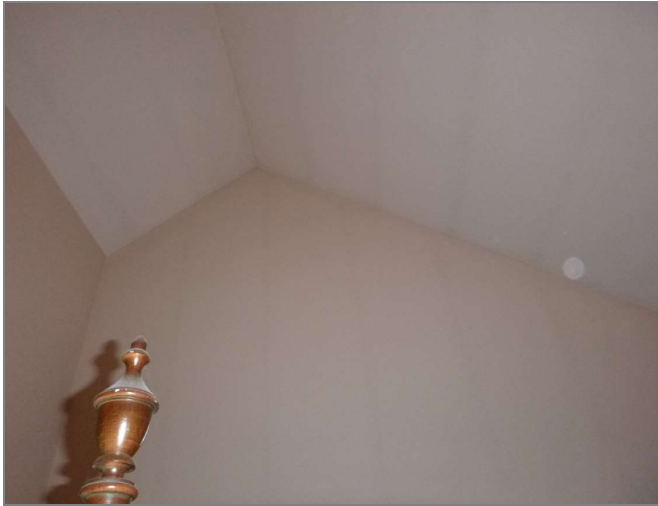
*Figure 3.1  
Unit 520  
"Stud shadowing" at vaulted ceiling*

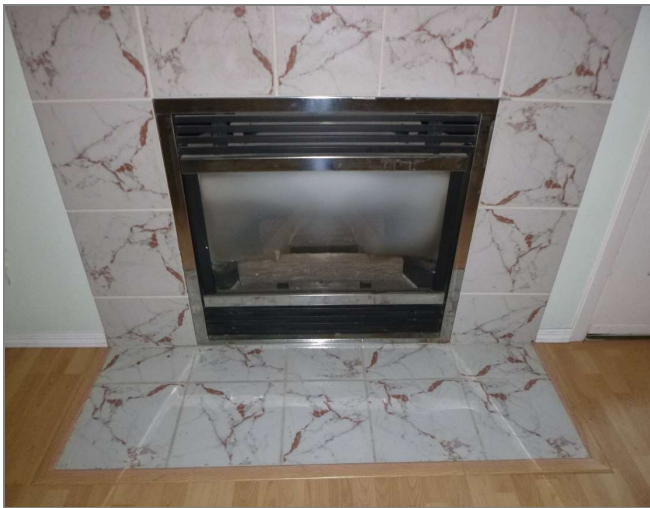
- Each unit has a central gas or electric furnace as well as a natural gas fireplace. Condensation is observed inside the fireplace at the unoccupied Unit 340.

*Figure 3.3  
Unit 340  
Fogging observed in gas  
fireplace*

We note that the natural gas fireplaces at the Quintet are not intended as primary heat sources. The residential units do not appear to be designed with air circulation to keep the whole unit at a consistent temperature and humidity. Therefore, heating with the fireplace will increase the temperature in one part of the unit, but not the rest. This condition may result in regions of the unit not being adequately heated and consequentially cause surfaces at windows and walls to fall below the dewpoint, resulting in condensation. Additionally, natural gas fireplaces are an inefficient heat source compared to an electric central furnace. We recommend that a qualified natural gas fireplace inspector be engaged on a regular basis to conduct inspection and repair.

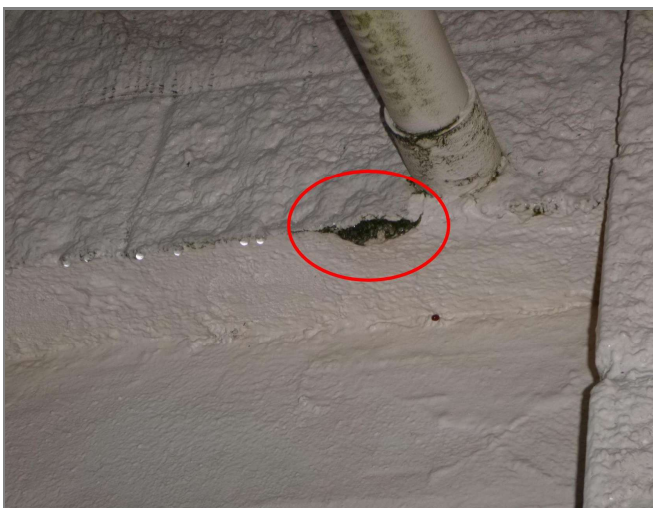
*Figure 3.10*  
*Building 1*  
*Failed coating below scupper*  
*at open-air corridor*

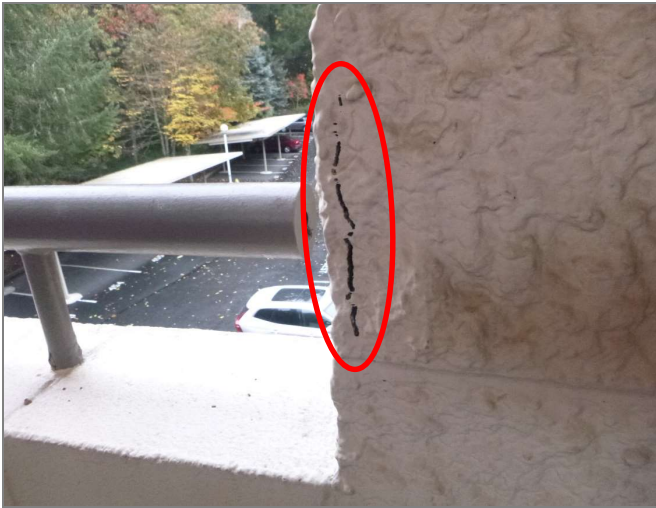
*Figure 3.11*  
*Building 5*  
*Crack in coating and CMU at open-air corridor*

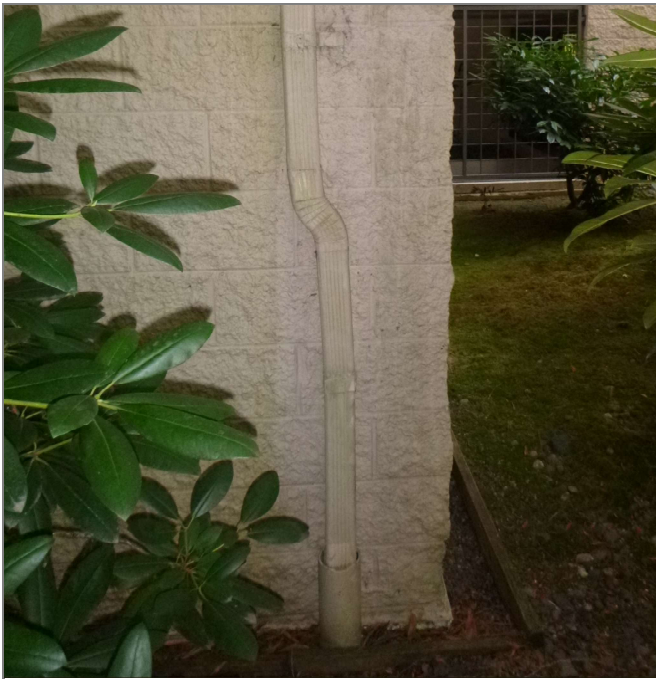
*Figure 3.12*  
*Building 5*  
*Organic staining at exterior CMU wall*

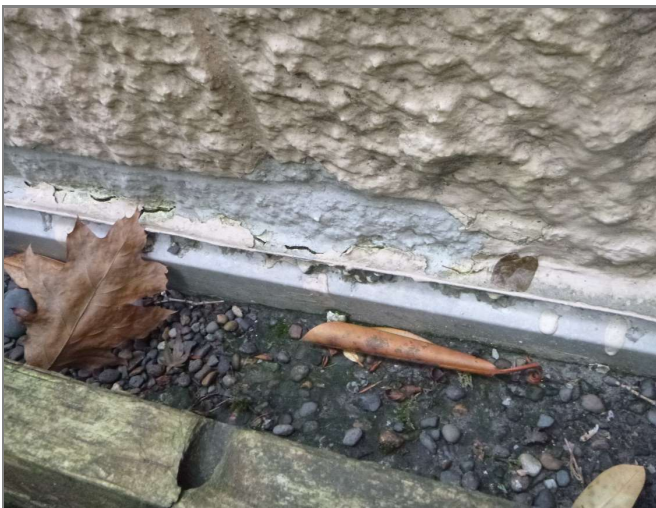
*Figure 3.13*  
*Building 5*  
*Failed coating at base of exterior wall*

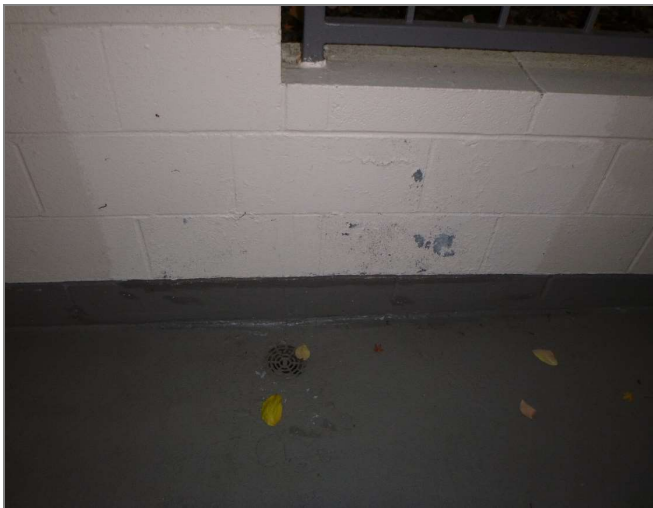
*Figure 3.14*

*Building 3*

*Abrasion wear on open-air corridor coating*

*Different colors of paint may indicate possible history of repairs.*

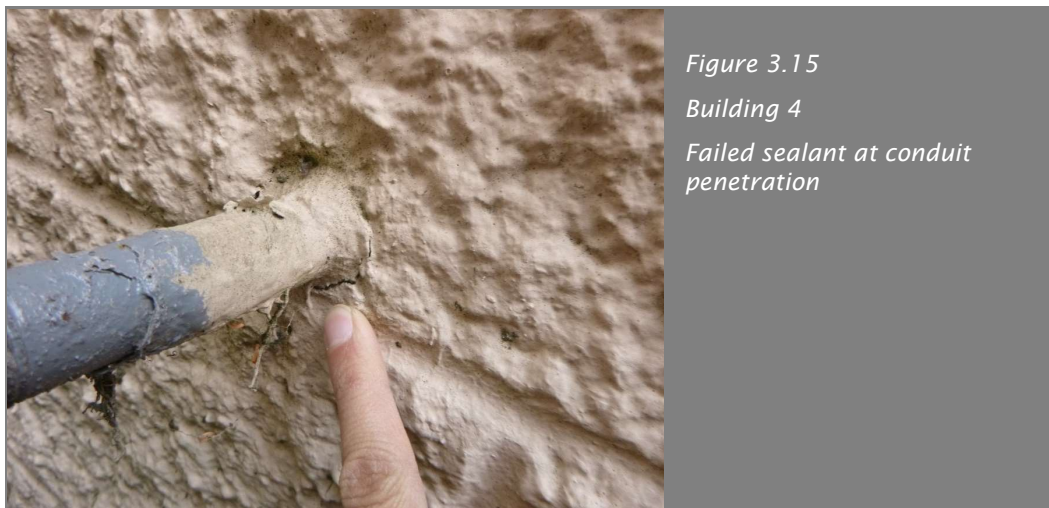
*Figure 3.15  
Building 4  
Failed sealant at conduit  
penetration*

- The perimeter sealant at wall mounted penetrations is failed or absent in multiple locations, including at light fixtures, balcony scuppers, exhaust vents, and conduit lines.
- Many intake/exhaust vents are missing horizontal slats and have had mesh inserts added to deter birds. Mesh inserts should not be installed on dryer vents as they are a life safety hazard and a code violation.

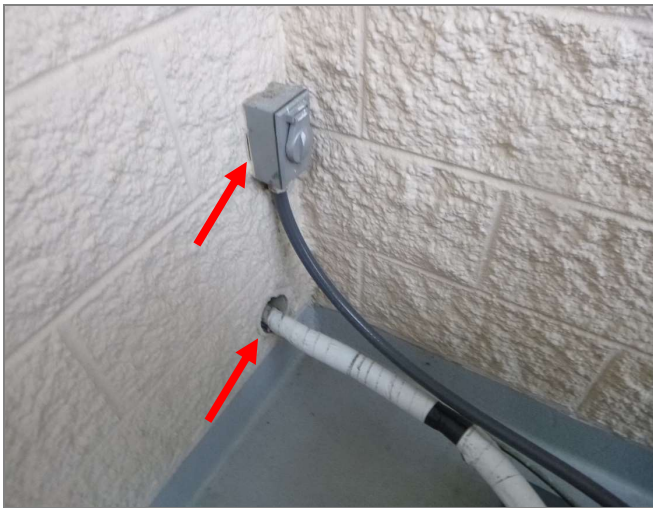
*Figure 3.16*  
*Building 4*  
*Failed and missing sealant at conduit penetrations at balcony wall*

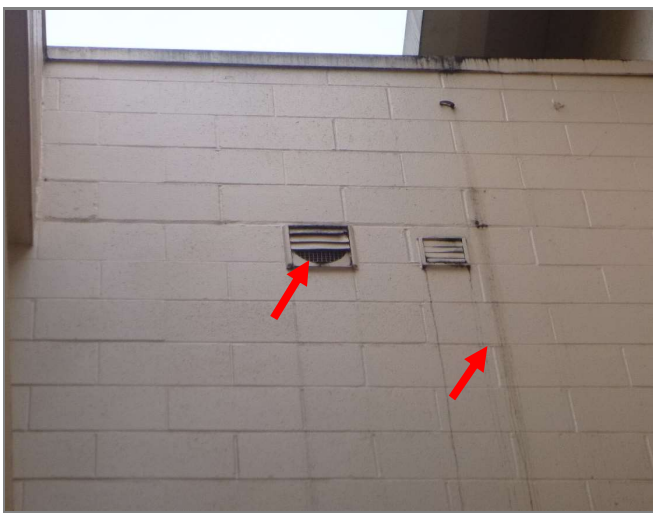
*Figure 3.17*  
*Building 1, Level 5*  
*Missing slats and staining at exhaust vents in open-air corridor*

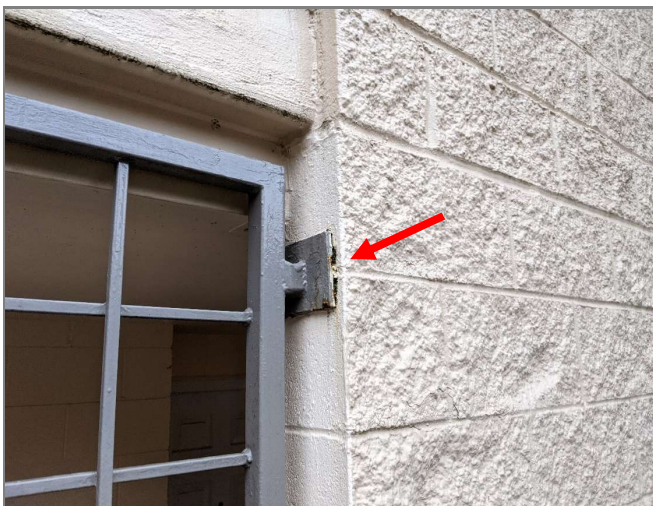
Figure 3.22  
Building 1  
Failed seal at corroding metal anchor mounts

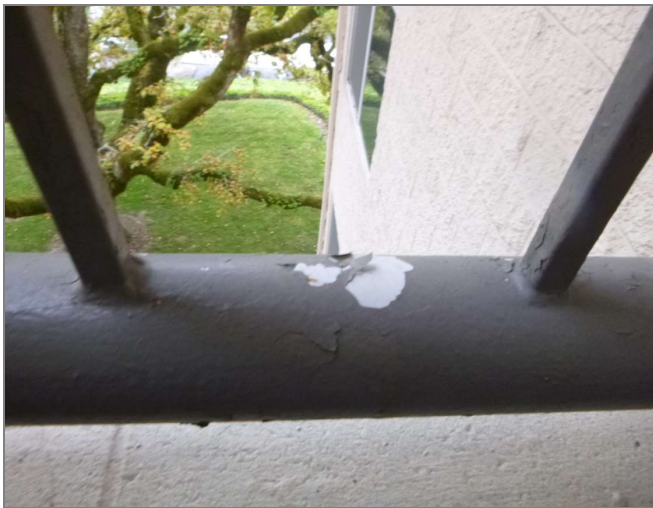
Handrails are also present at the guard walls of individual unit balconies. The coating on guard wall metal railings is often cracking and peeling.

Figure 3.23  
Building 5  
Peeled coating at metal railing

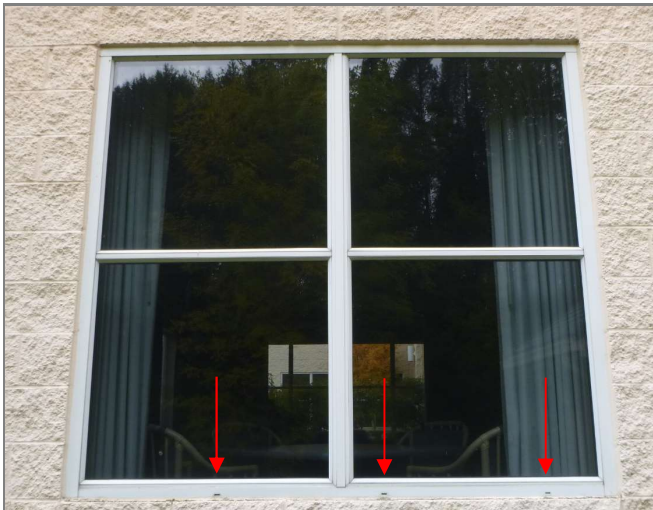
Figure 3.28  
Clubhouse south elevation  
4-pane exterior-glazed fixed  
windows. Note inconsistently  
spaced weeps.

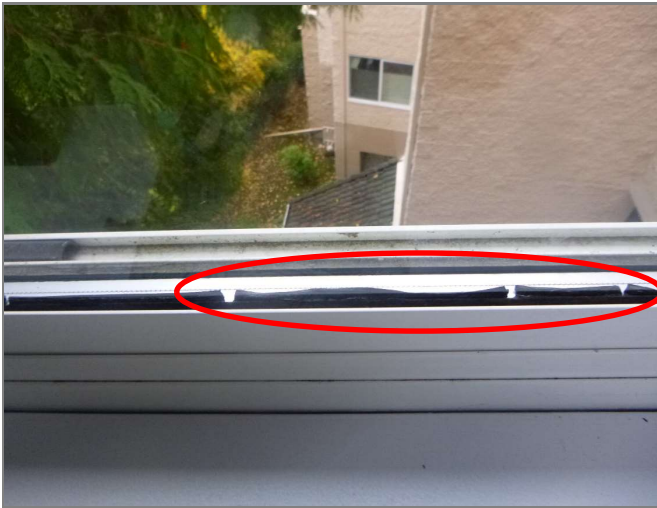
Figure 3.30  
Unit 243  
Failed glazing putty

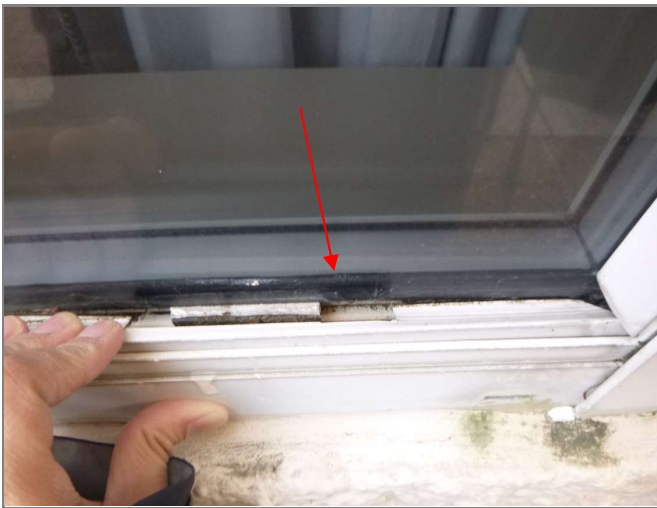
Figure 3.31  
Clubhouse west elevation.  
Damaged glazing cap leading  
to missing/discontinuous  
glazing gasket.

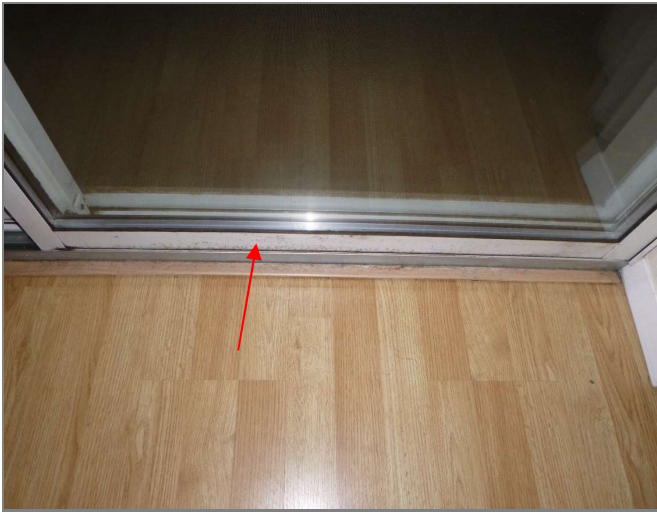
Figure 3.36  
Unit 126  
Organic growth/staining at  
frame.

- Aluminum sliding glass doors at residential units often show signs of organic growth at the frame and adjacent interior finishes. Occasionally there is condensation on the frame and lower portions of glass, near the threshold.
- Some aluminum sliding glass doors have damaged or displaced glazing gaskets.
- Operation of aluminum sliding doors is typically acceptable. Some doors are difficult to operate and lock.
- We did not observe condensation at the new vinyl sliding glass door systems reviewed.

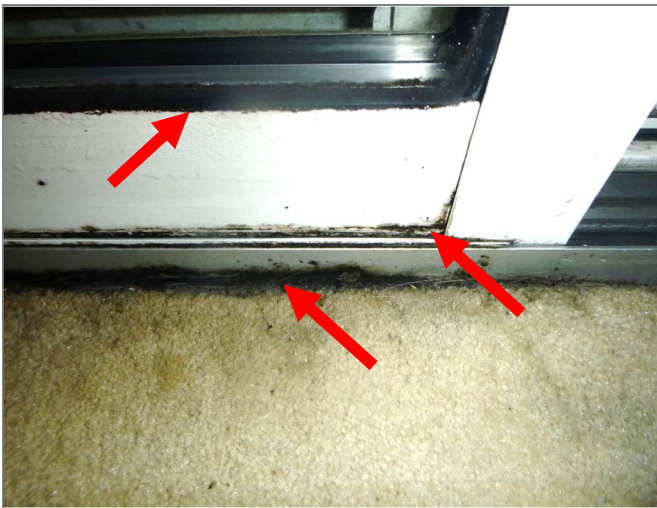
Figure 3.38  
Unit 427  
Condensation and organic  
growth on sliding door glass,  
sliding door frame, and carpet

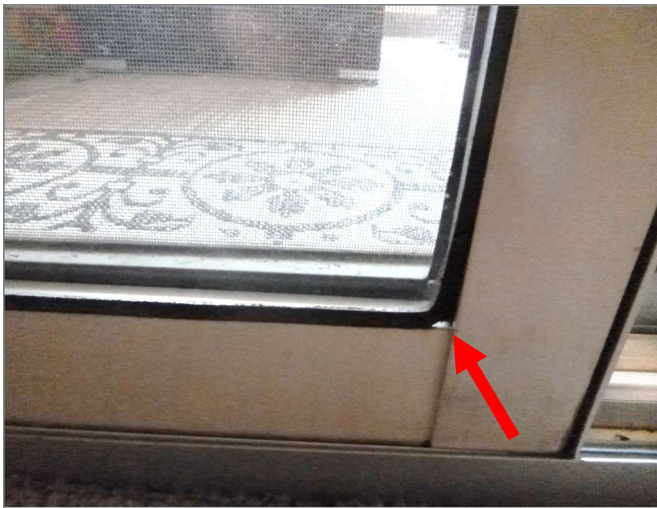
Figure 3.39  
Unit 143  
Displaced rubber gasket

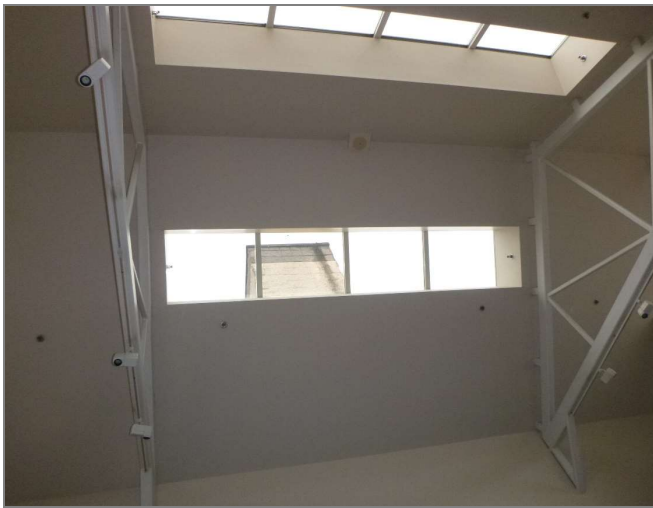
Skylights are present at the clubhouse atrium. Skylights appear to be a similar configuration to the aluminum-framed storefront system. We did not closely review the skylight assemblies. Skylights should be routinely inspected and cleaned to ensure acceptable performance for the remainder of their service life.

*Figure 3.40  
Clubhouse atrium skylights.*

RECOMMENDATION	
21	<b>Maintenance:</b> Inspect and clean skylights twice annually.

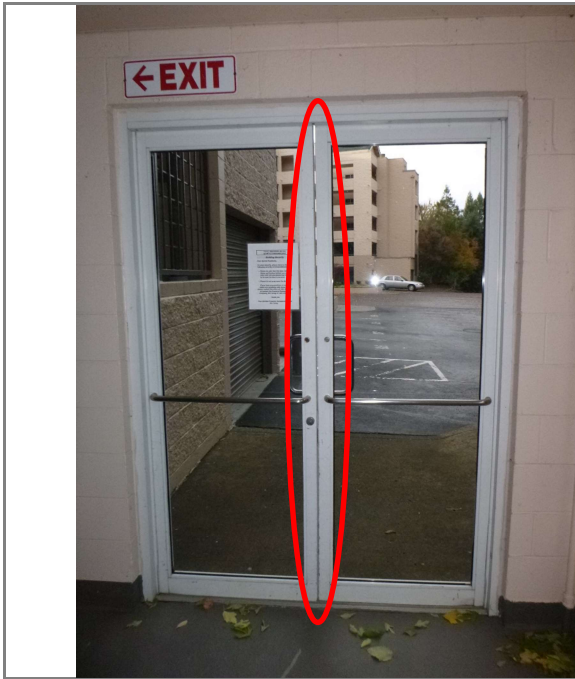
*Figure 3.48  
Building 1  
Gap between aluminum doors*

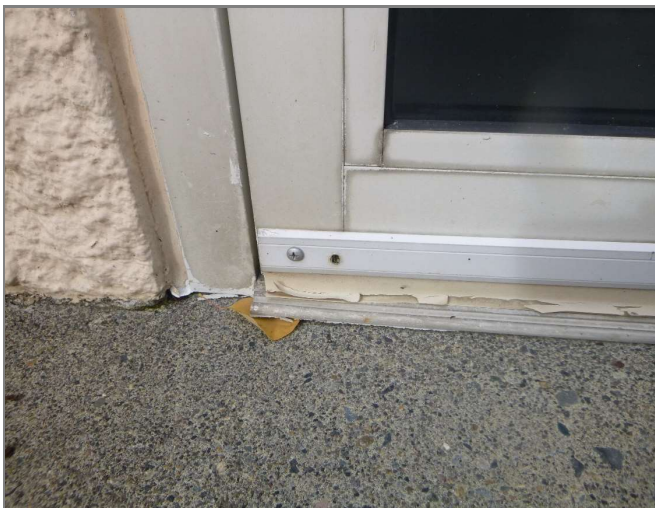
(Building 2). Additionally, failed sealants and damaged sweeps are observed at the door sill.

*Figure 3.49  
Clubhouse south elevation  
Failed sealants and sweep.*

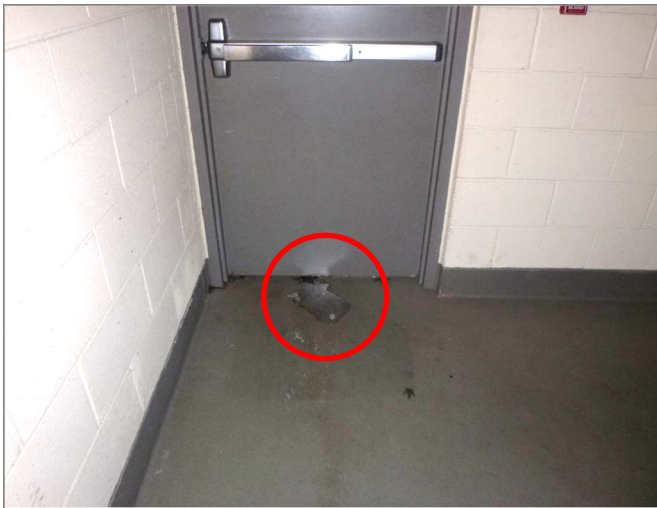
- There is often a large gap at the bottom of the hollow metal egress doors. At some door locations, the exterior walkway is backsloped towards the building and water enters the open-air corridors through the gap under the door.
- Many of the exterior front doors at residential units have damaged or missing weatherstripping and door sweeps.

*Figure 3.53*  
*Building 4*  
*Water ingress below metal hollow core egress door*

Unit doors constitute a separation between conditioned and unconditioned spaces, and should be a priority for maintenance. Failed weather stripping and sweeps at unit entries and balcony doors should be replaced with new materials.

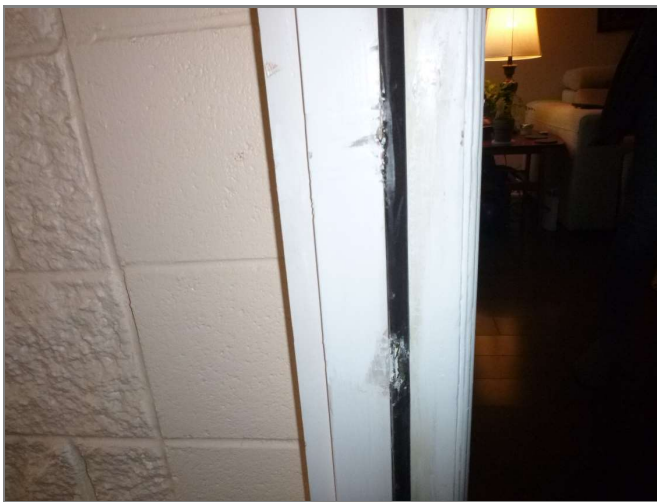
*Figure 3.54*  
*Unit 216*  
*Damaged weatherstripping*

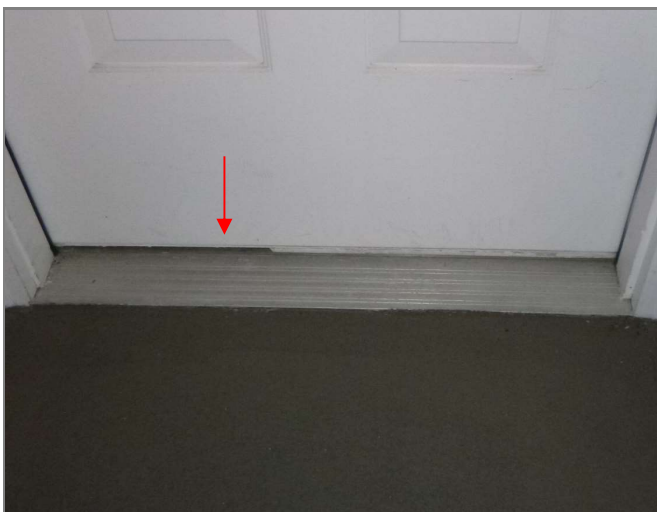
*Figure 3.55*  
*Unit 340*  
*Damaged sweep*

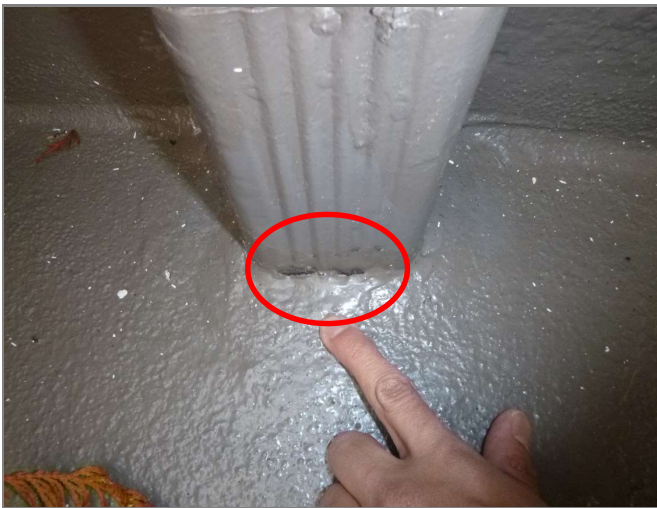
*Figure 3.59  
Unit 340  
Failed coating at downspout  
penetration*

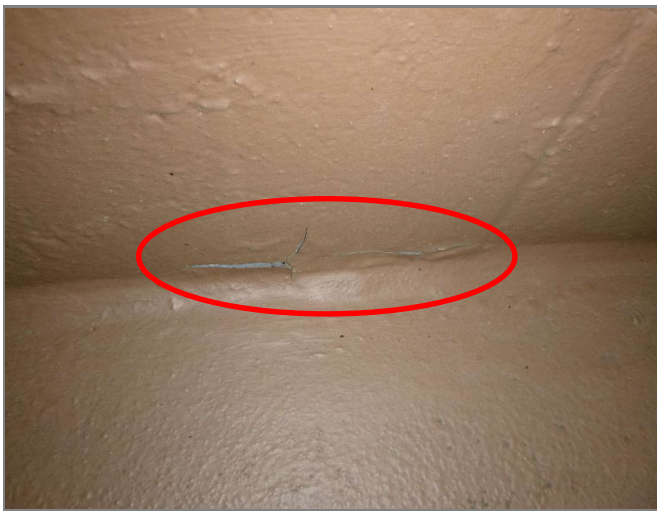
*Figure 3.62*  
*Unit 524*  
*Failed coating at floor to wall*  
*transition*

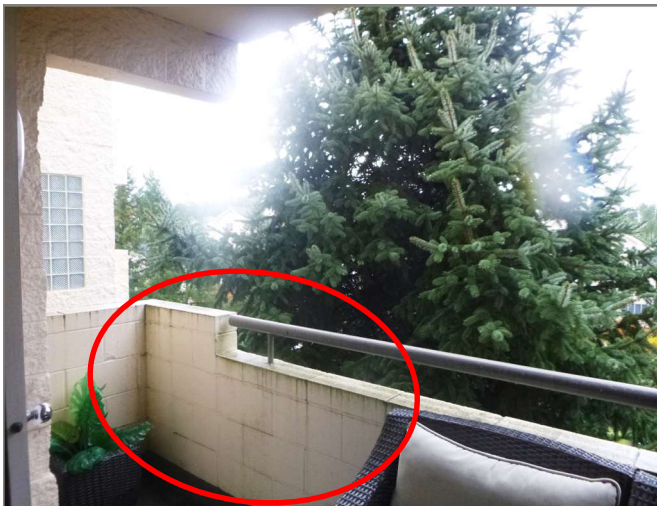
*Figure 3.63*  
*Unit 427*  
*High levels of organic staining*  
*at balcony horizontal and*  
*vertical surfaces adjacent to*  
*tree*

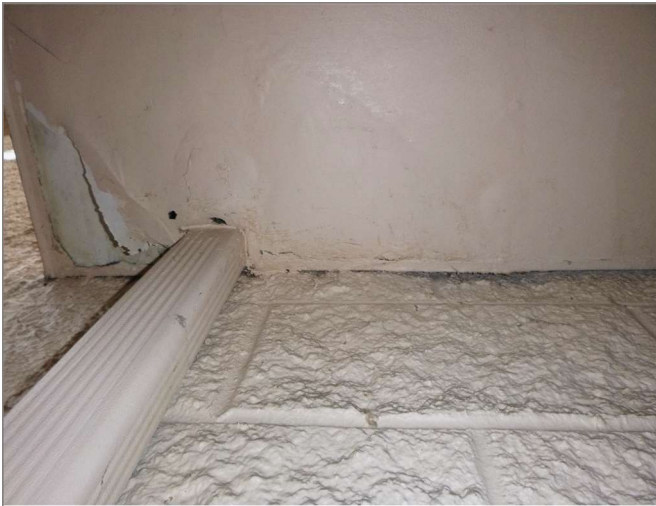
*Figure 3.64  
Unit 520  
Blistering coating and gypsum board at soffit with downspout penetration*

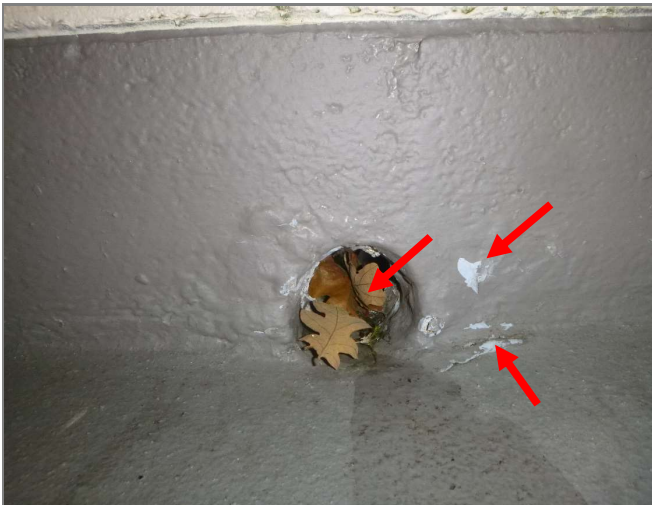
Figure 3.71  
Building 5  
Debris in scupper and failed coating at walkway

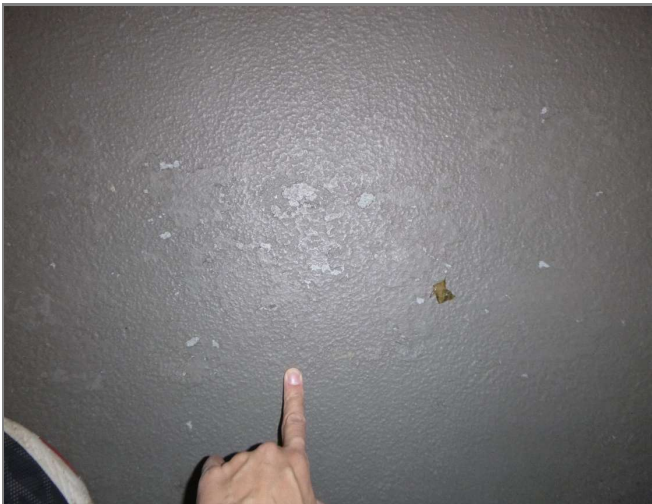
Figure 3.72  
Typical localized failure of coating at open-air corridor floors where coating is worn off, revealing the lighter surface below

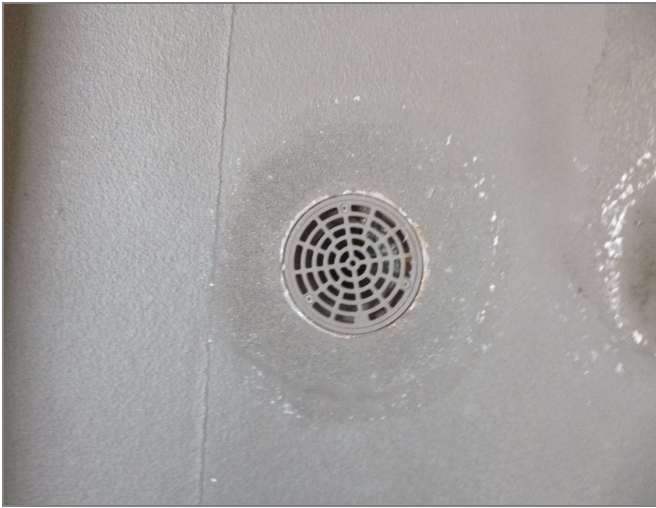
*Figure 3.73  
Building 1  
Chipped and worn coating at  
drain flange.*

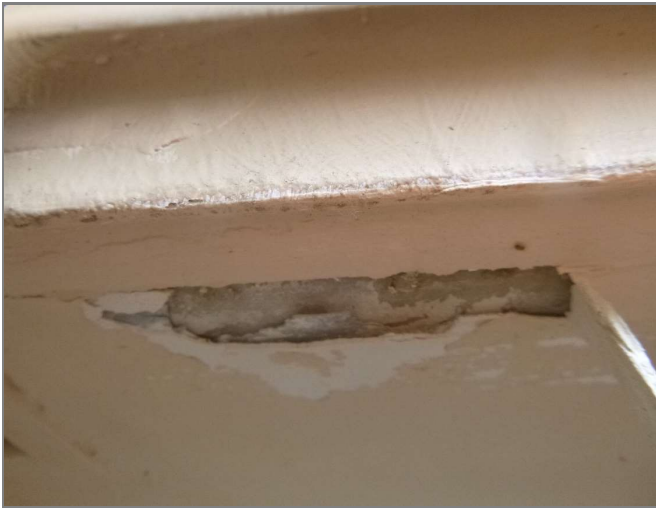
*Figure 3.74  
Building 1  
Failed coating and spalling  
gypsum board at corridor  
ceiling*

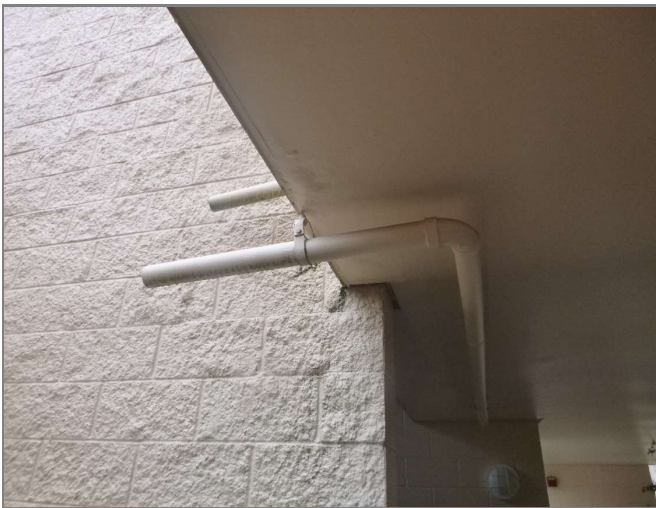
*Figure 3.75  
Building 1  
Drain pipe at underside of  
floor in Figure 3.73*

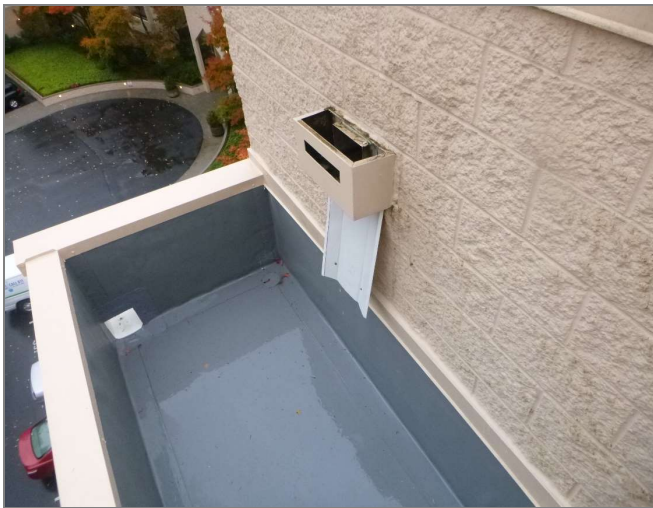
The installation of the roofing was incomplete at the time of our review and RDH is not involved in its design or construction. Standing water at low-slope roofs can lead to premature degradation of the roof membrane. These roof areas should be monitored for signs of ponding water and other drainage and leak issues. Any deficiencies should be corrected by the roofer within the installer’s warranty period, typically one year from completion.

Figure 3.76  
New roofing installation in-progress at Building 4

RECOMMENDATION	
37	<b>Maintenance:</b> Monitor new roof areas for standing water and drainage deficiencies. Deficiencies to be corrected by the roofer during the installer's warranty period.

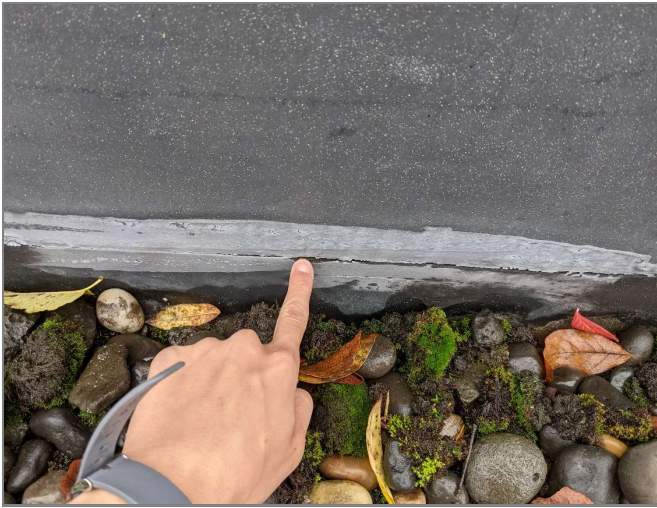
*Figure 3.78  
Building 2  
Failed seal at patch to roofing  
membrane*

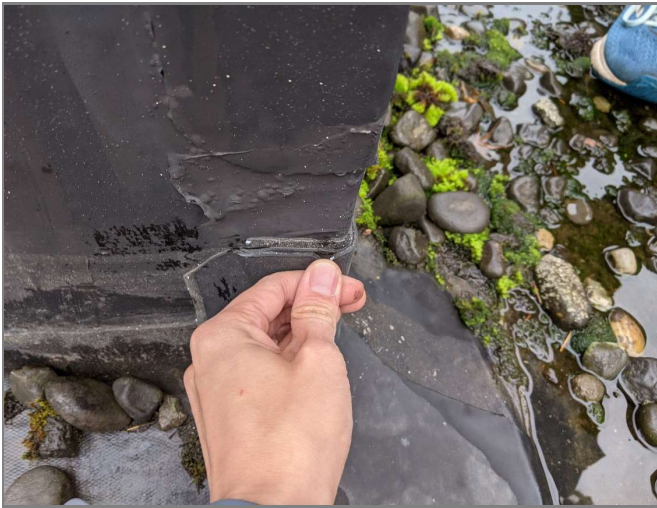
*Figure 3.79  
Building 2  
Failed seal at roofing  
membrane corner up-turn  
detail*

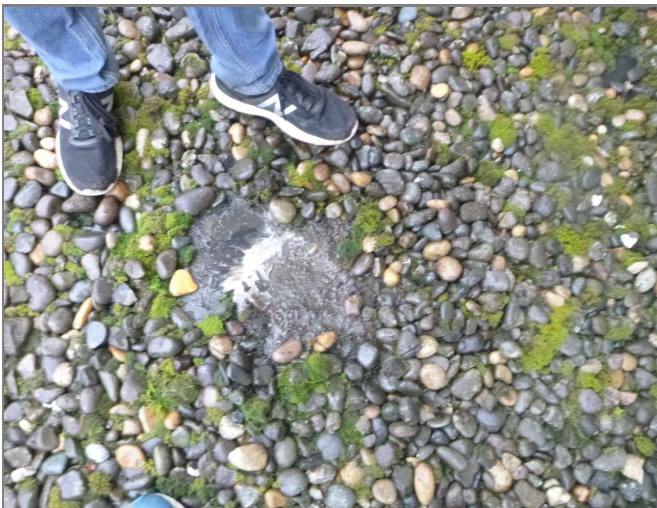
*Figure 3.80  
Building 5  
Crack repair in EPDM  
membrane. UV degradation  
(crazing) is present due to  
exposure.*

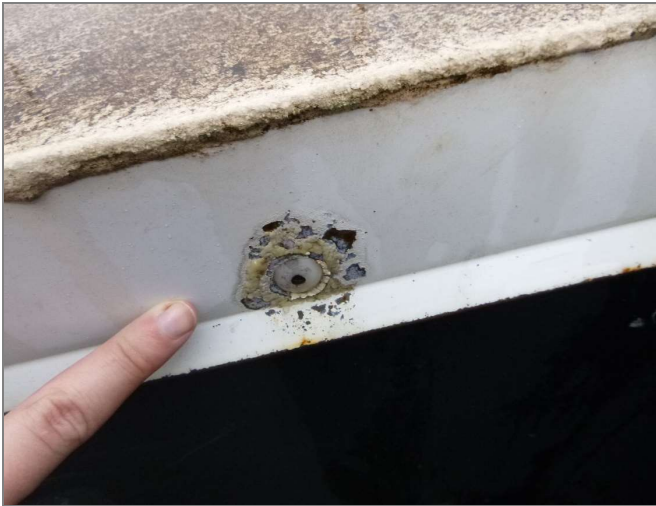
*Figure 3.81  
Building 4  
Missing sealant at flashing  
fastener*

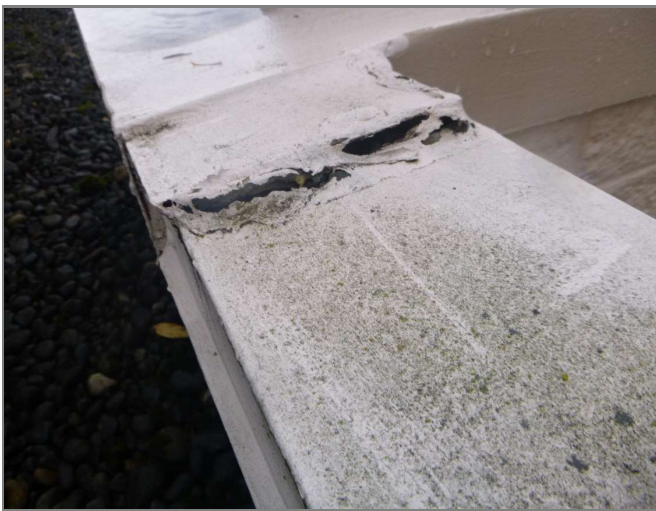
*Figure 3.82  
Building 2  
Failed sealant at coping lap*

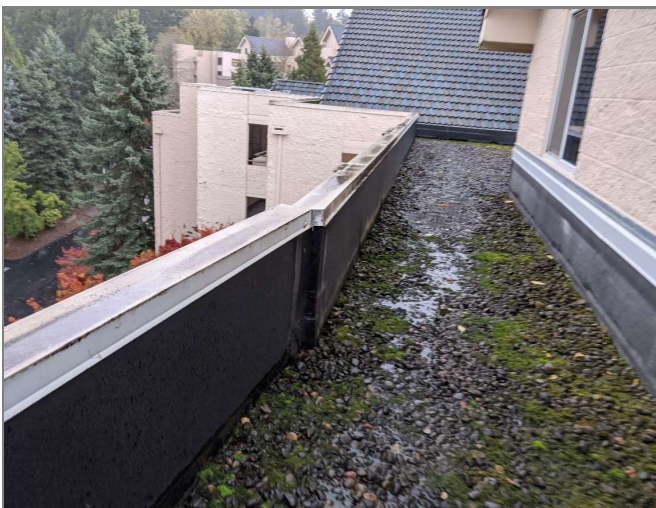
*Figure 3.83  
Building 3  
Typical unwanted organic  
growth and standing water on  
roof ballast*

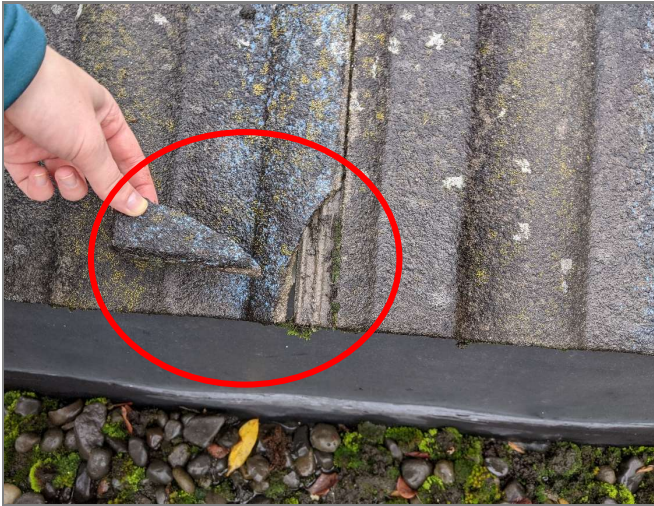
*Figure 3.84  
Cracked concrete tile at  
Building 2 roof*

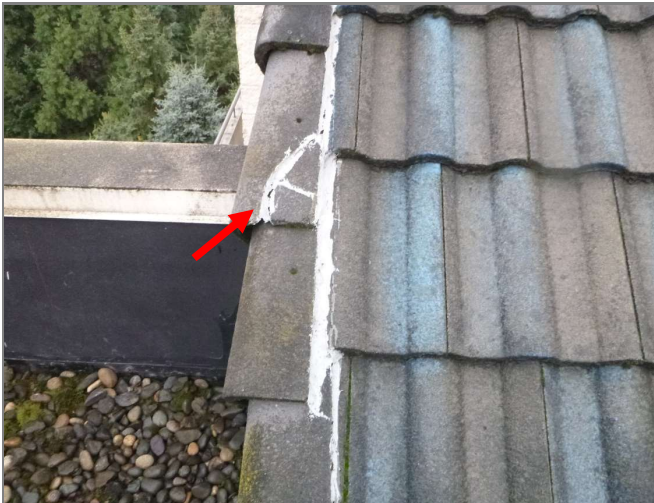
*Figure 3.85  
Building 5  
Failed sealant repair at  
concrete tiles.  
Sealant is not a permanent  
solution to address leaks  
between concrete tiles.*

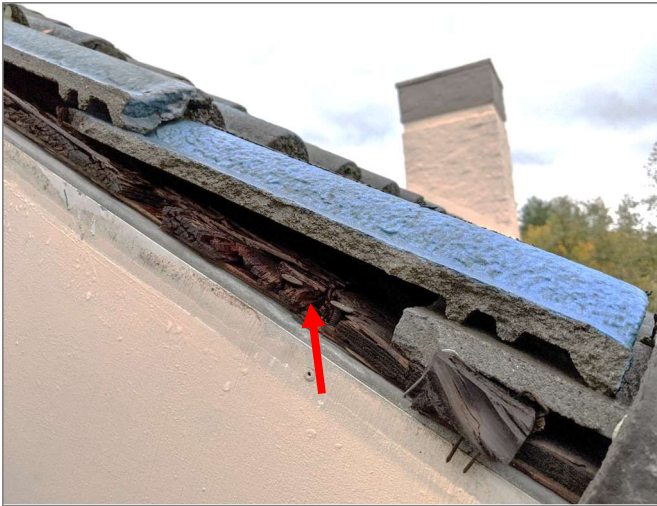
Figure 3.86  
Building 2  
Missing tiles at gable end  
reveal deteriorated plywood  
sheathing

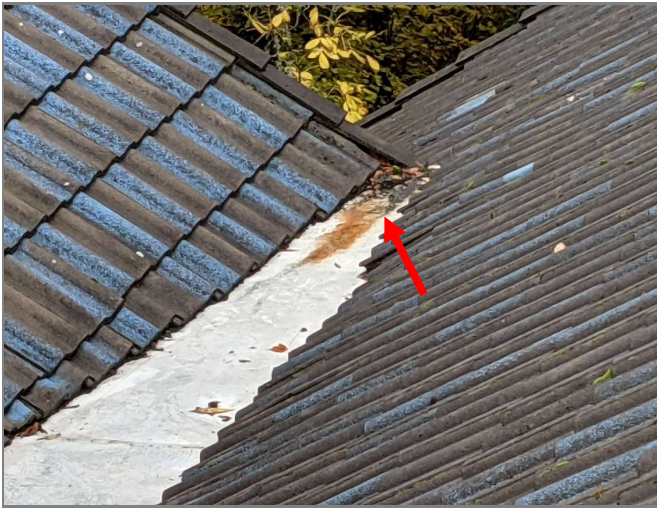
Figure 3.87  
Debris and standing water at  
cricket valley between  
adjacent gabled roofs

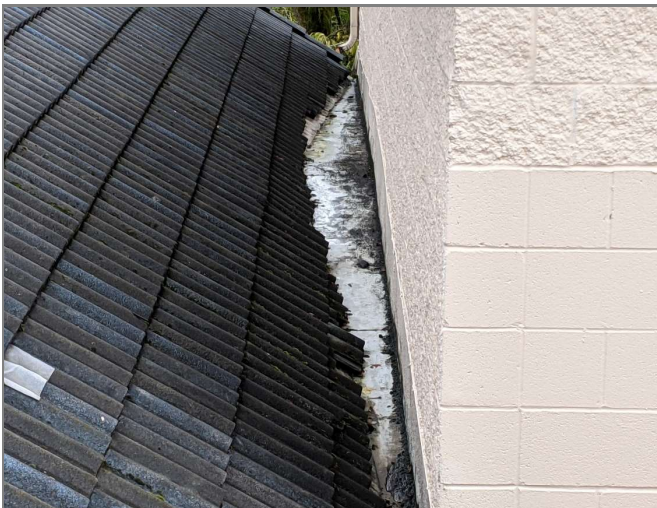
Figure 3.88  
Typical valley to wall metal  
flashing transition with debris  
accumulation

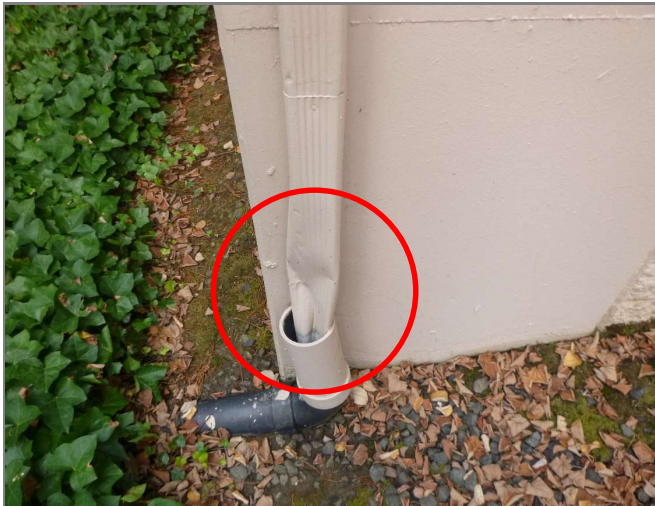
*Figure 3.90  
Building 5  
Damaged downspout at transition to grade*

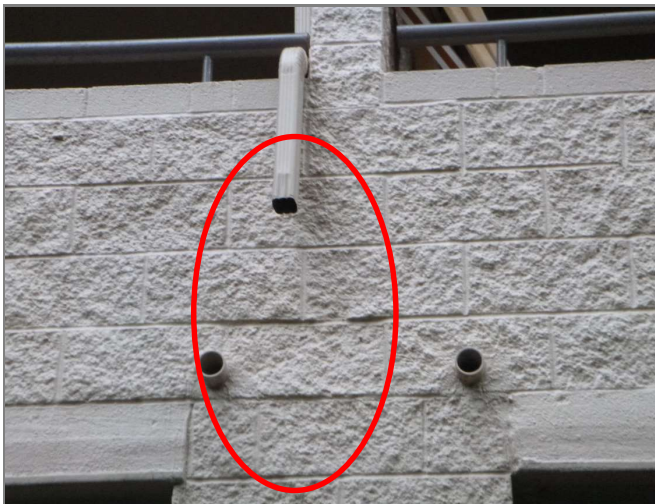
*Figure 3.91  
Building 2  
Missing section of downspout*

- Some sections of downspout are displaced from their intended drainage path, damaged, or are missing entirely

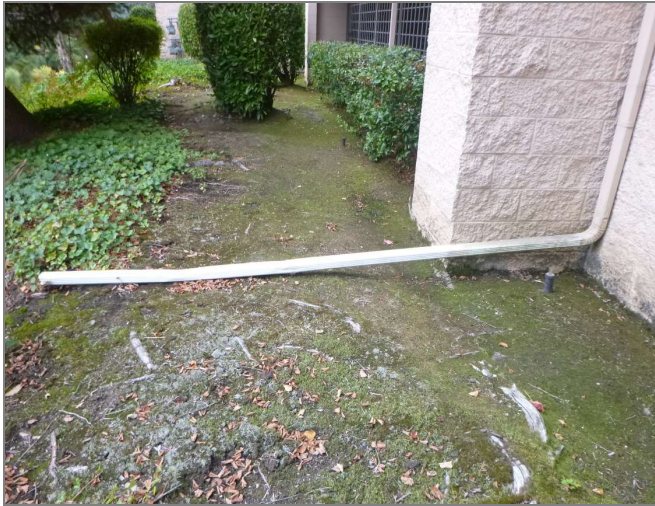
*Figure 3.92  
Building 4  
Extension on downspout where  
grade slopes back towards  
building*

- Downspouts at the rear of buildings drain onto grade. Some of the downspouts have been extended to drain far away from the buildings where the grade slopes towards the building

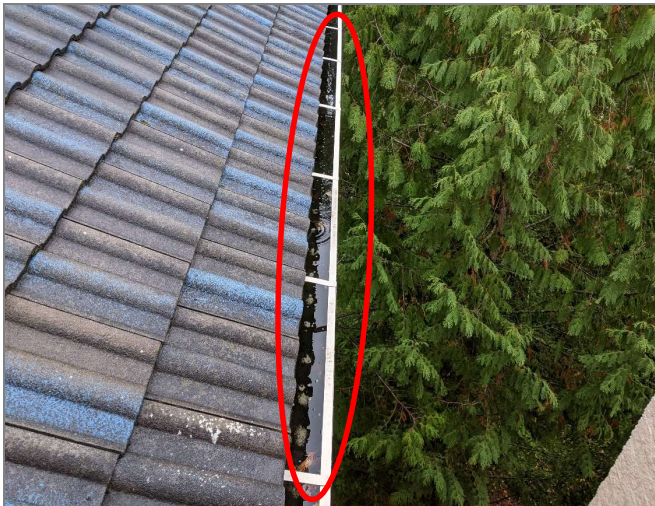
*Figure 3.93  
Building 2  
Standing water in gutter at  
sloped roof*

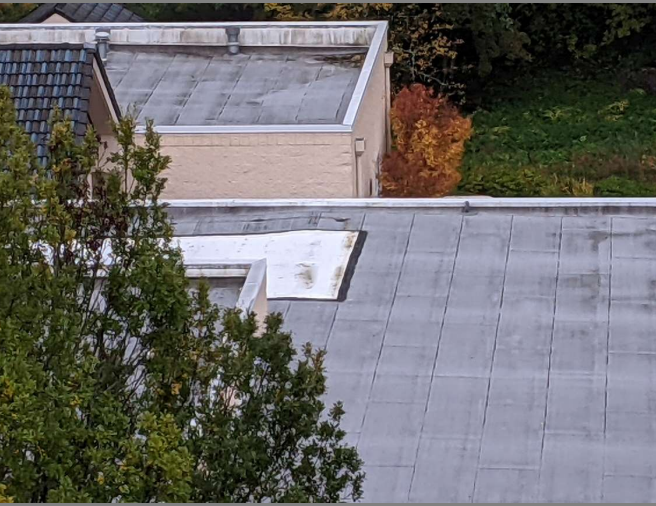
*Figure 3.95  
Apparent repair patch at center of roof area.*

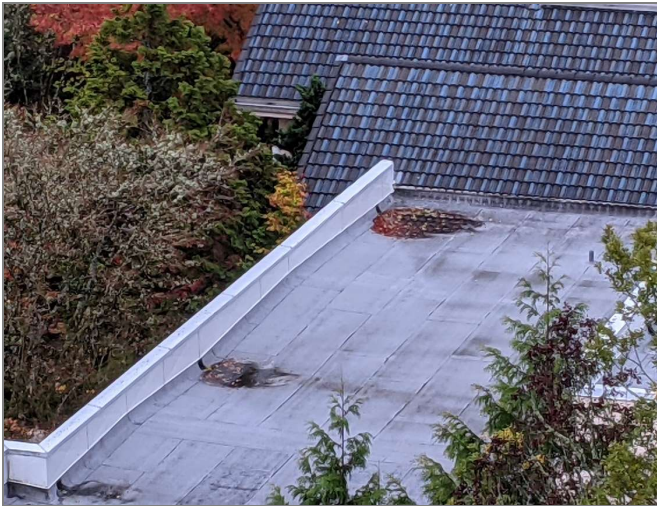
*Figure 3.96  
Debris accumulation at  
scuppers.*

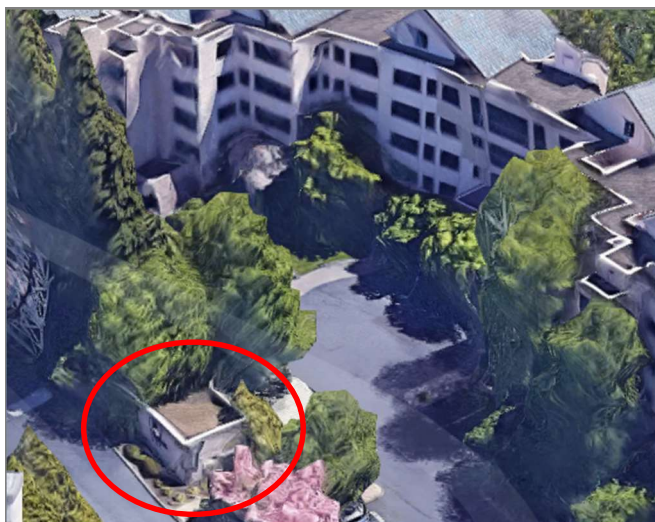
*Figure 3.99  
Pump House Roof as viewed  
from Google Maps.*

We did not closely review the pump house but understand that the roof consists of EPDM membrane of similar age to the main roofs. We recommend replacing this roof at the same time as the main roofs with the same roofing material.

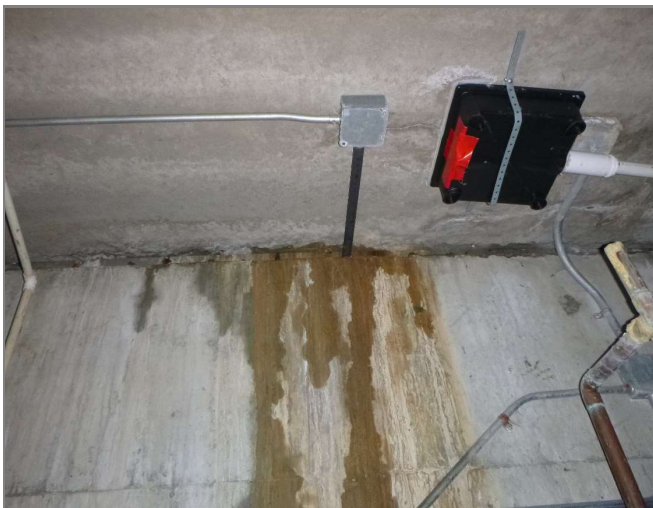
*Figure 3.100*

*Building 3*

*Active leak at conduit penetration at joint between wall and floor slab, located beneath raised planter*

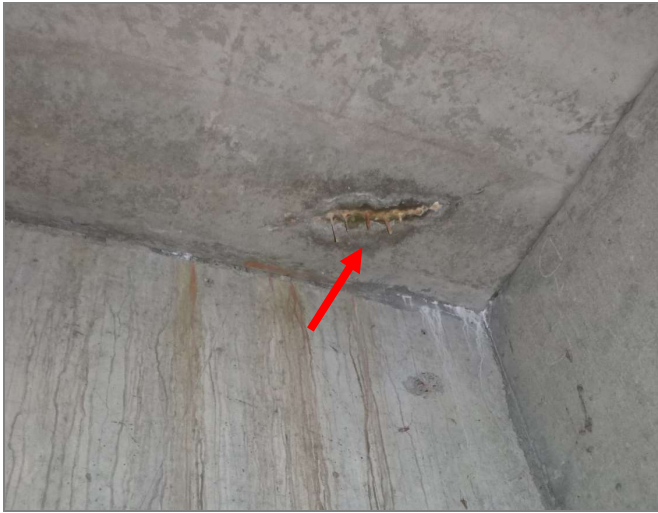
*Figure 3.101*  
*Building 3*  
*Mineral deposits at underside*  
*of hollow-core slab*

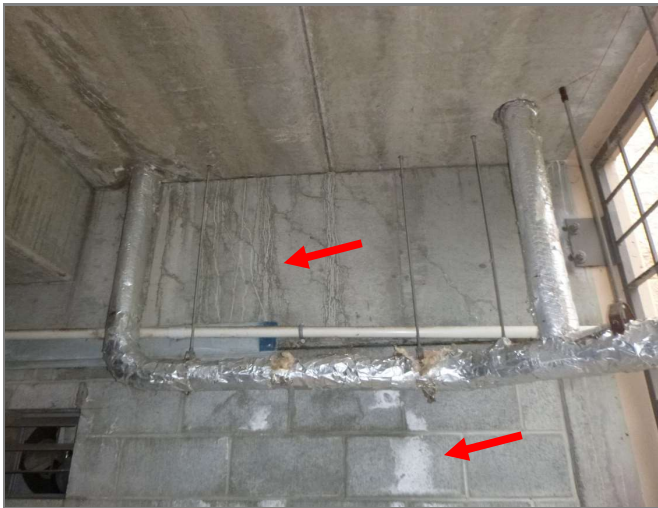
*Figure 3.102*  
*Building 3*  
*Efflorescence and staining at*  
*the cast-in-place concrete and*  
*CMU walls*

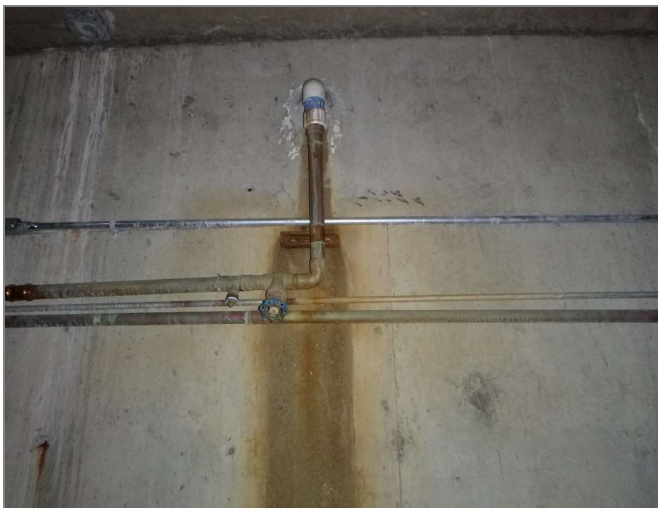
*Figure 3.103*  
*Building 4*  
*Rust staining below conduit*  
*penetration at cast-in-place*  
*concrete wall*

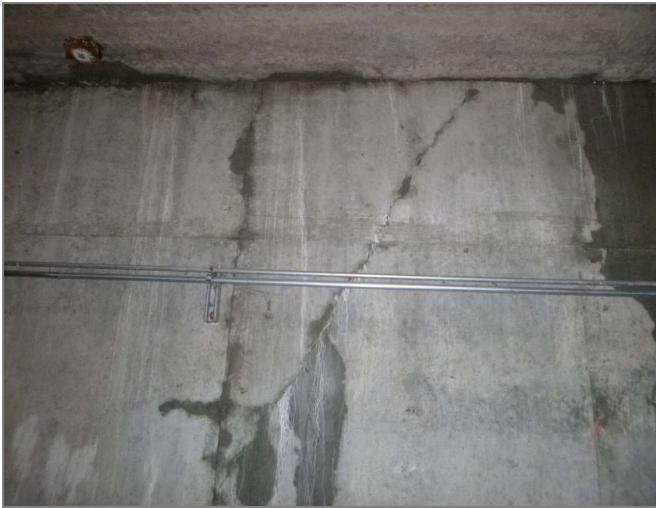
*Figure 3.104*  
*Building 1*  
*Water leaking through crack*  
*at cast-in-place concrete wall*

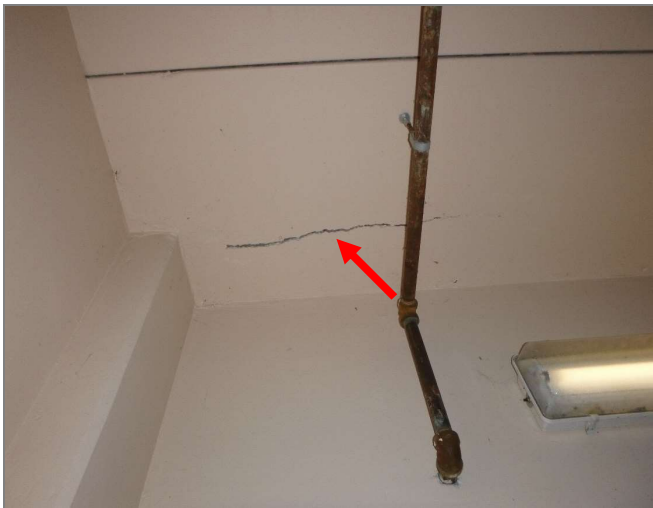
*Figure 3.107*  
*Building 3*  
*Crack at stairwell*

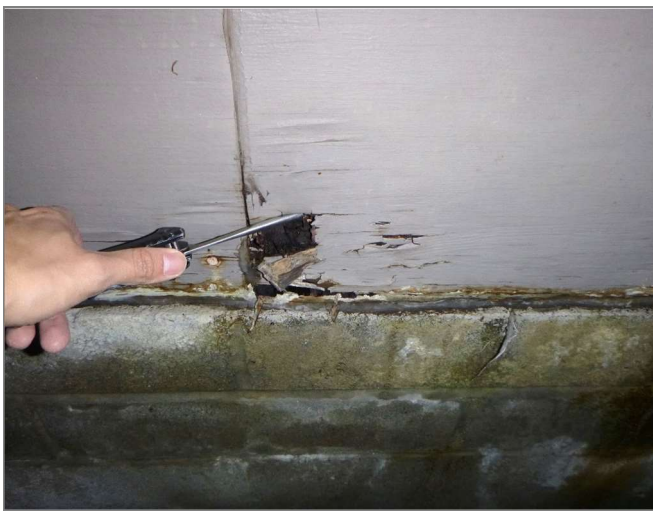
*Figure 3.108*  
*Building 5*  
*Deteriorated plywood installed in wall opening*

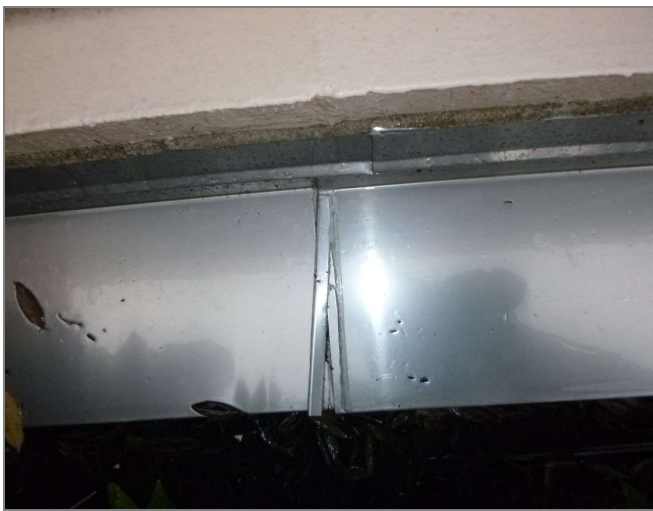
Figure 3.111  
Building 1  
Failed sealant and flat seam  
at base flashing lap
