To Jimmy Songvilay  
Kin Living  
139 SE Taylor Street, Suite 200  
Portland OR 97214

Revised March 14, 2022 by  
RDH Building Science Inc.  
5331 SW Macadam Avenue #314  
Portland OR 97239

RDH Building Science Inc. (RDH) was retained by Kin Living to undertake an assessment of the current condition of the building enclosure of the buildings at the Quintet Condominiums complex located at 6695 W. Burnside Road, Portland, OR.

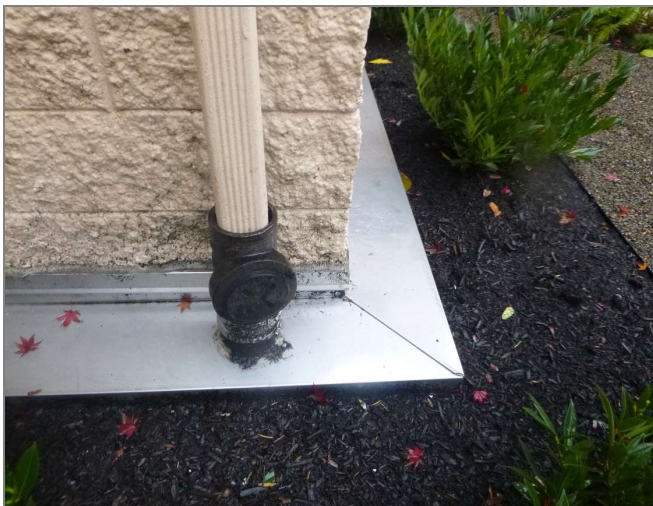
Figure 3.112  
Building 1  
Downspout penetrates base  
flashing

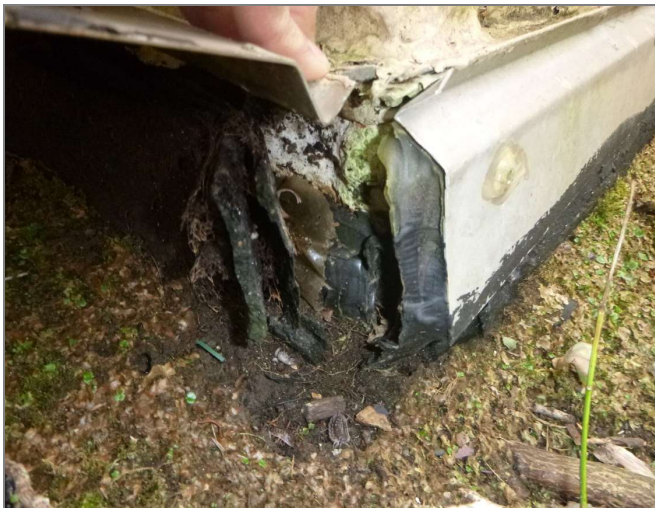
*Figure 3.114  
Building 4  
Discontinuous termination bar  
with failed sealant*

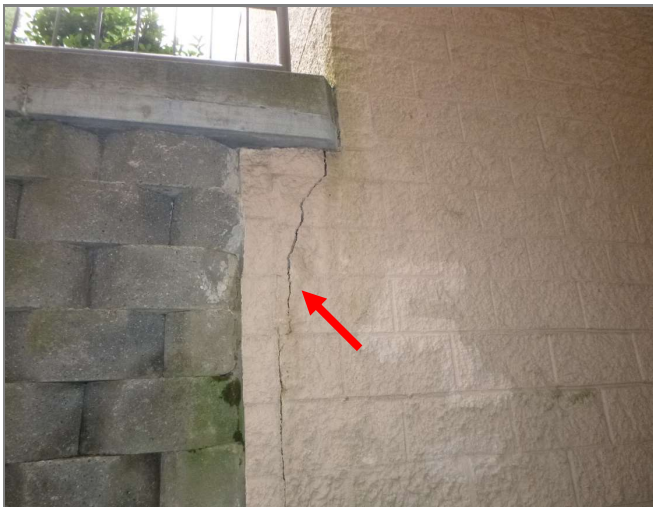
The retaining walls interface with the CMU walls and foundation walls. At Building 5, cracks are forming in the CMU wall at the interface with the retaining wall. At Building 4, rebar is protruding from the ground near the retaining wall, and is possibly part of a footing.

*Figure 3.115  
Building 5  
Crack in CMU at retaining wall  
at perimeter of raised planter*
