THE QUINTET CONDOMINIUMS

6605-6645 W Burnside, Portland, OR 97210

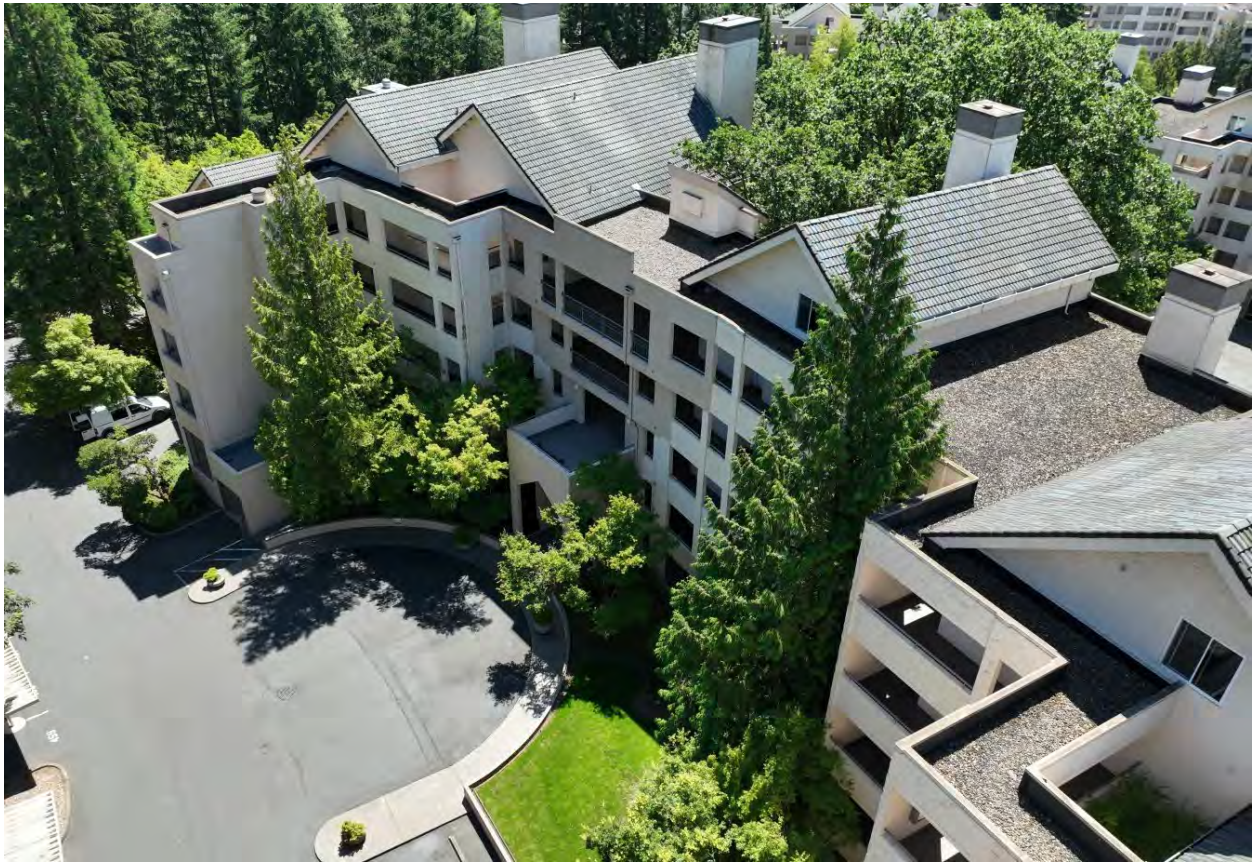
| Property Type | Multifamily - Condominiums |

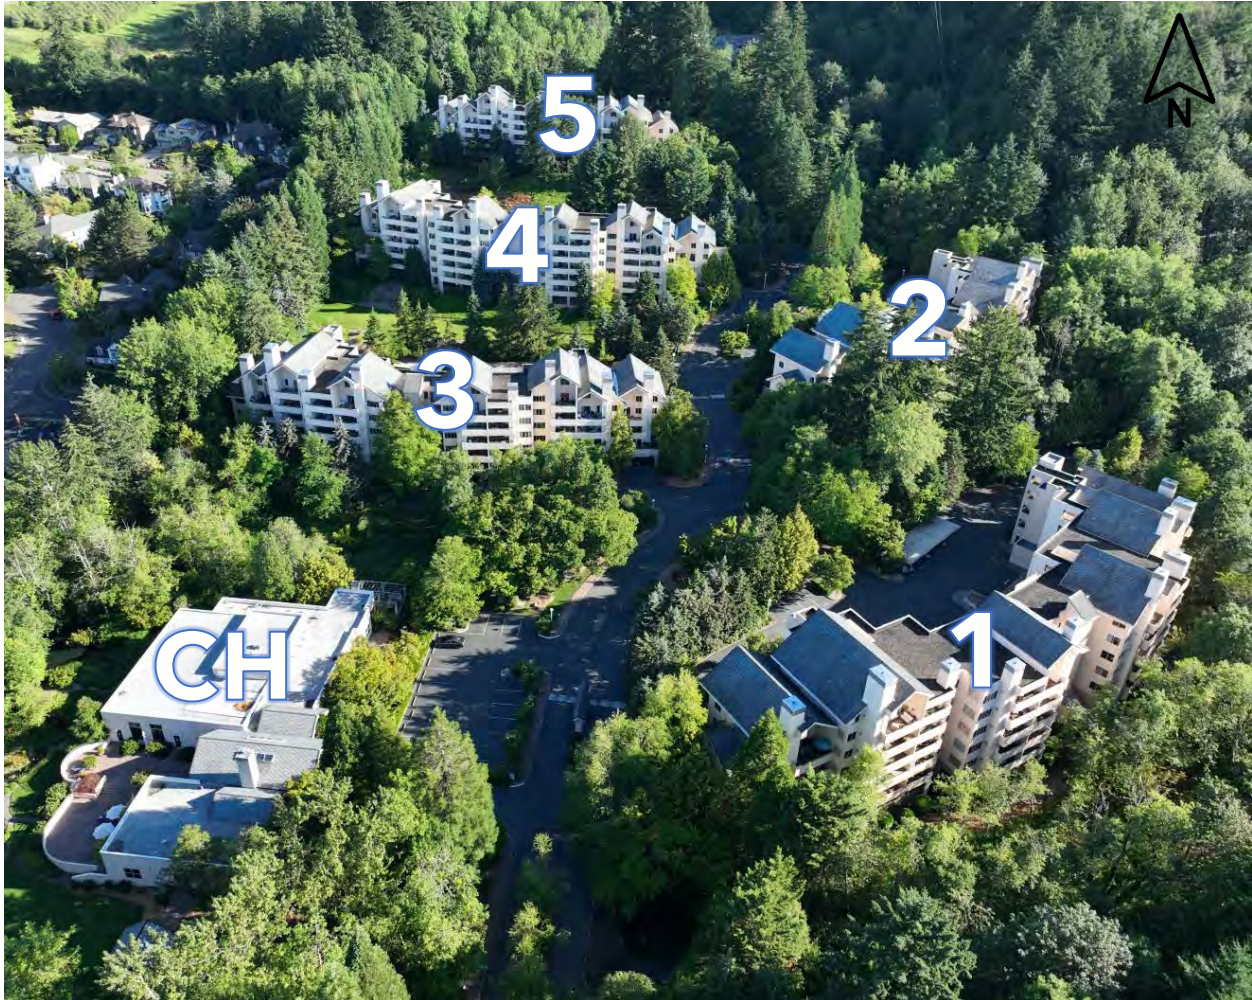
- Bldg. 1: 6605 W Burnside - The Sequoia Bldg. (45 units)
- Bldg. 2: 6625 W Burnside - The Dogwood Bldg. (40 units)
- Bldg. 3: 6685 W Burnside - The Cascade Bldg. (40 units)
- Bldg. 4: 6665 W Burnside - The Maplewood Bldg. (45 units)
- Bldg. 5: 6645 W Burnside - The Oak Pointe Bldg. (35 units)
- CH = Clubhouse: 6695 W Burnside

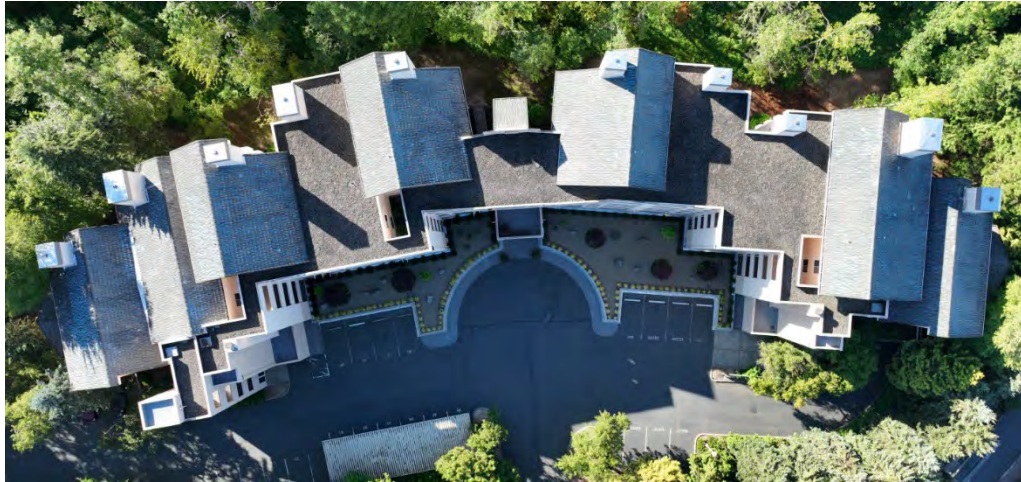
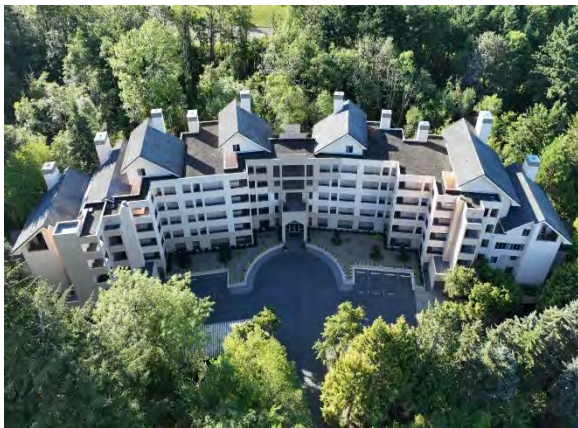
Bldg. 1: 6605 W Burnside - The Sequoia Bldg.

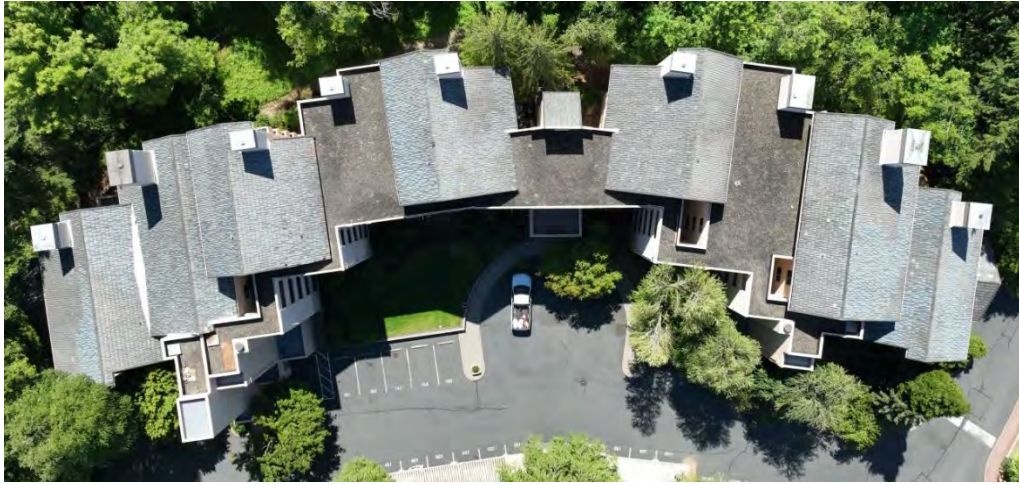
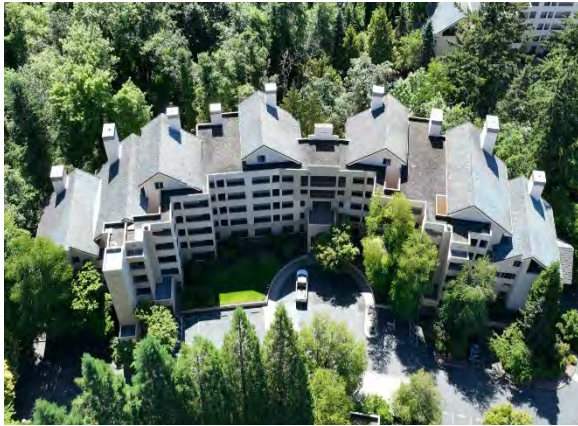
Bldg. 2: 6625 W Burnside - The Dogwood Bldg.

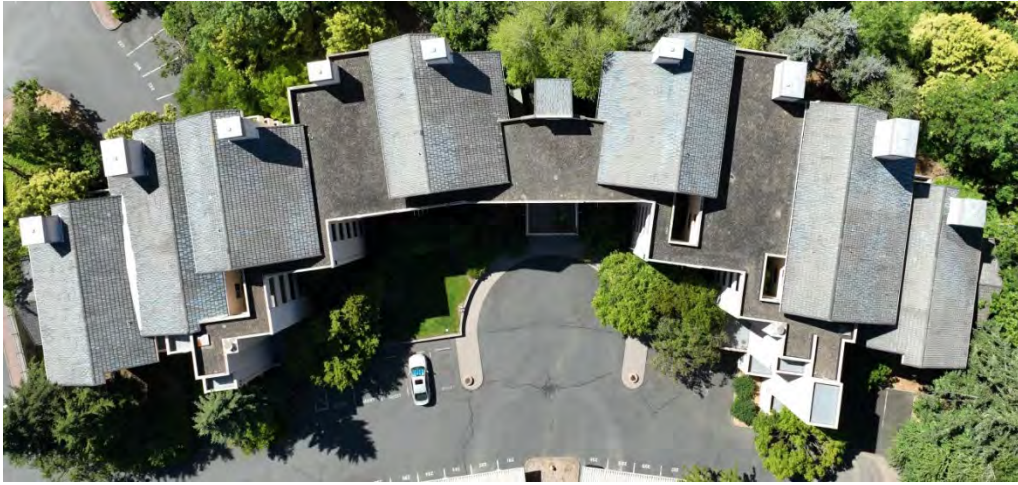
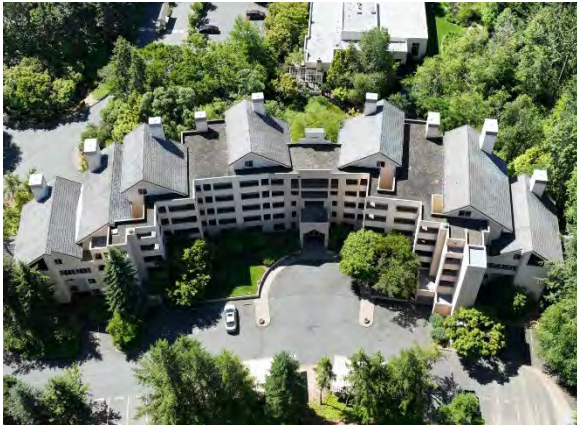
Bldg. 3: 6685 W Burnside - The Cascade Bldg.

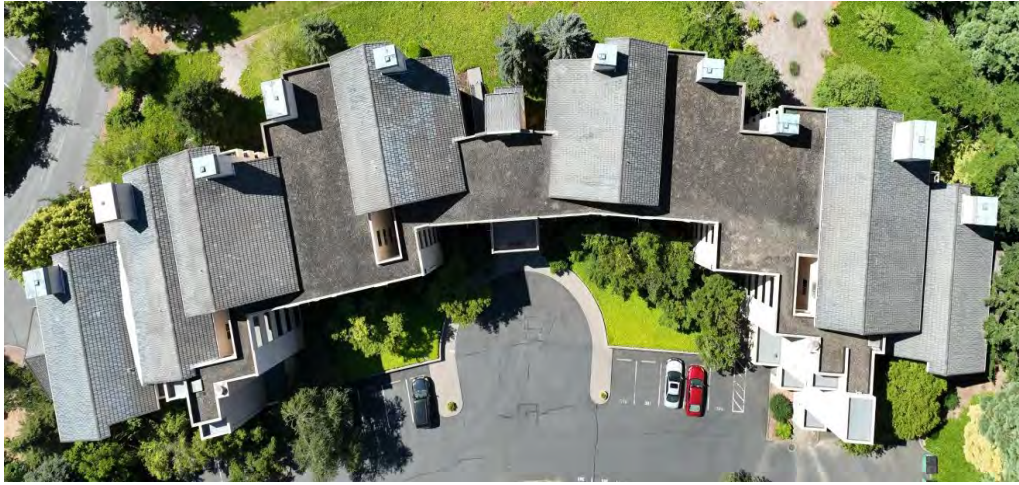
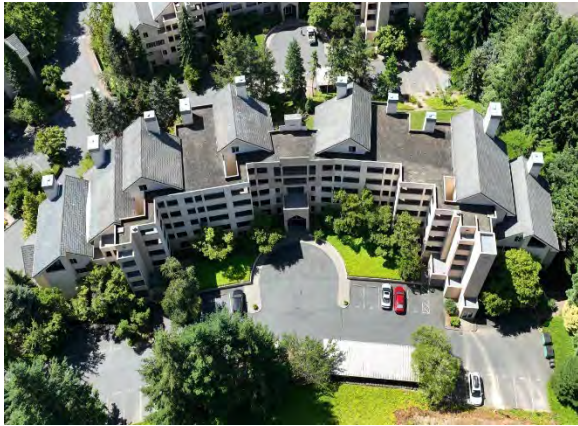
Bldg. 4: 6665 W Burnside - The Maplewood Bldg.

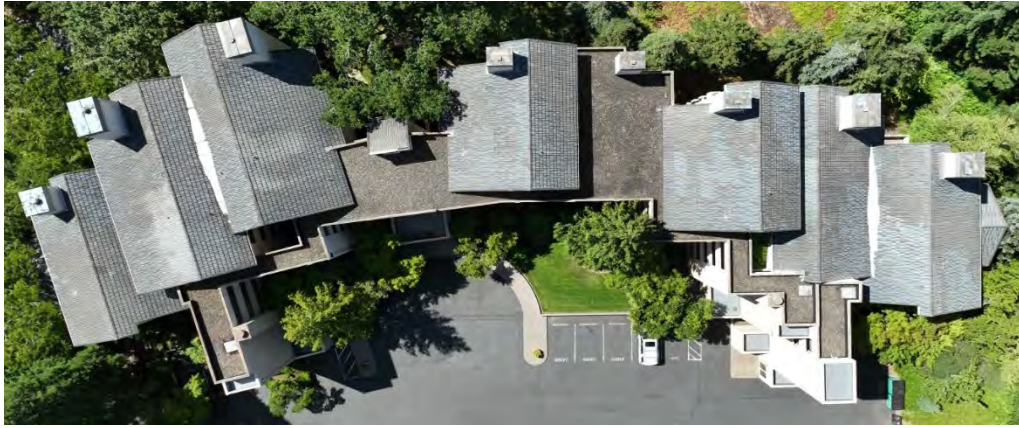
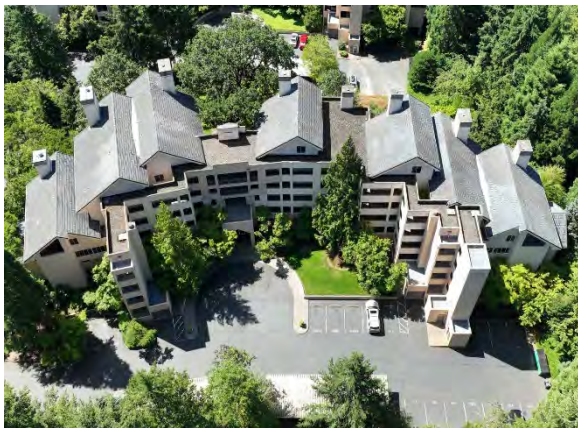
Bldg. 5: 6645 W Burnside - The Oak Pointe Bldg.

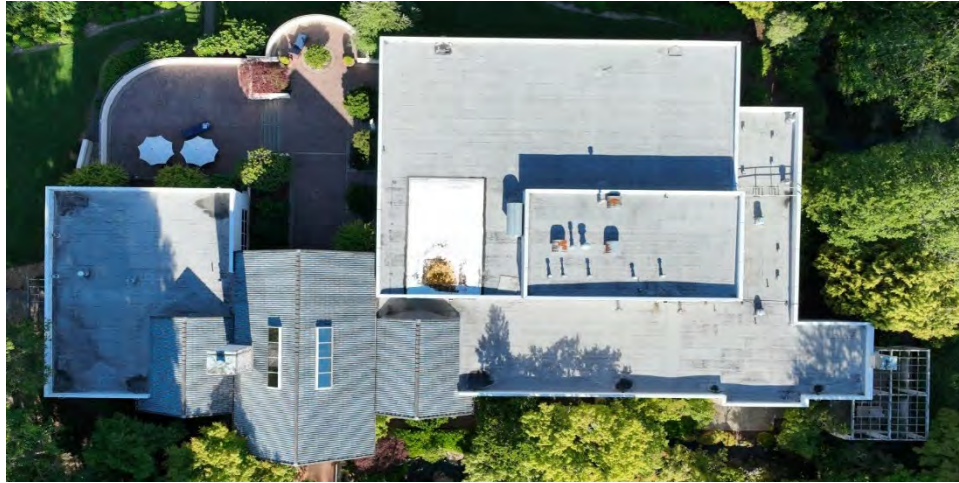
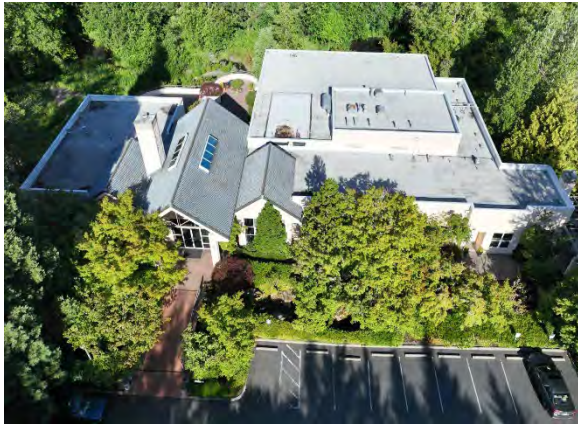
Clubhouse: 6695 W Burnside

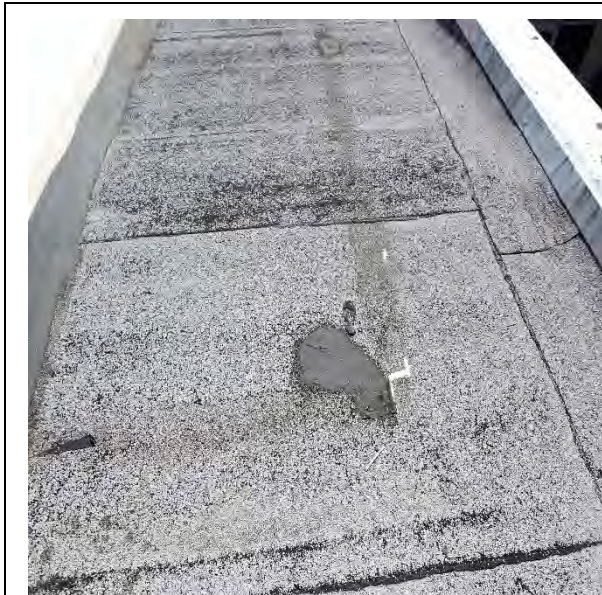
2.1A Roof sheathing is decayed. Note, previously patched holes.
Location: Clubhouse

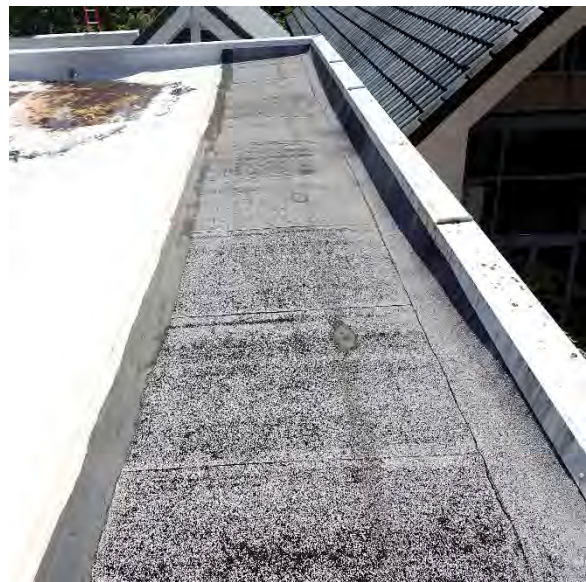
2.1B Additional view of decayed roof sheathing with previously patched holes.

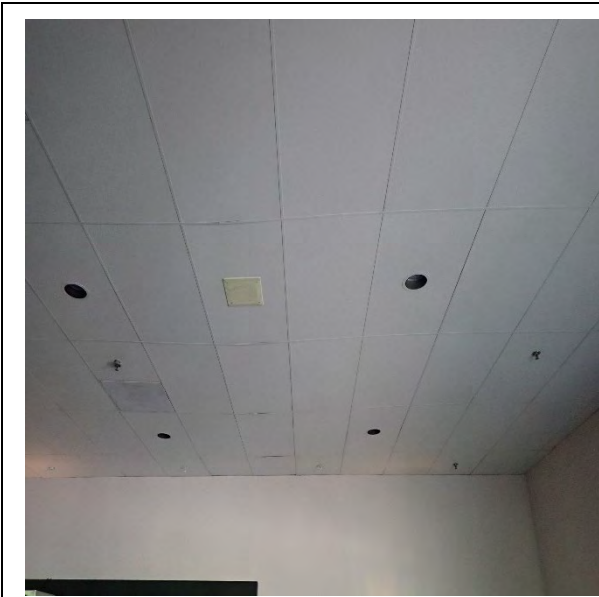
2.1C Interior view of drip ceiling sagging below damaged roof areas.

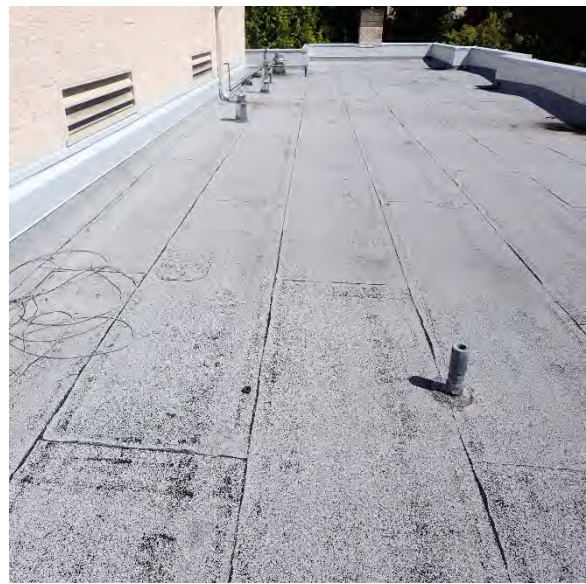
2.2 Granule loss is occurring on modified cap sheet sooner than typical. Further review is required to determine cause of premature granule loss.

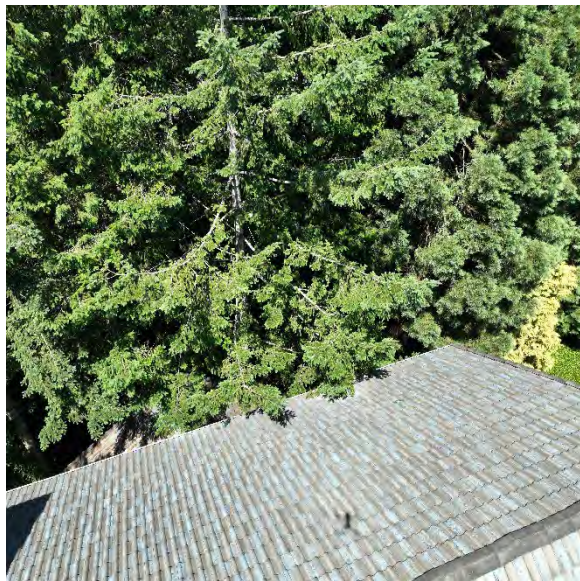
2.3 Tree extends over edge of roof. Vegetation should be trimmed back a minimum 2' from edge of roof.

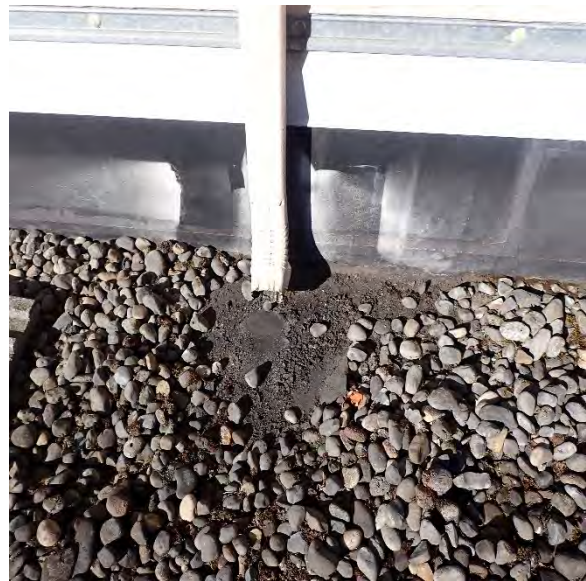
2.4 Splash blocks are missing at base of downspouts on EPDM roofs.

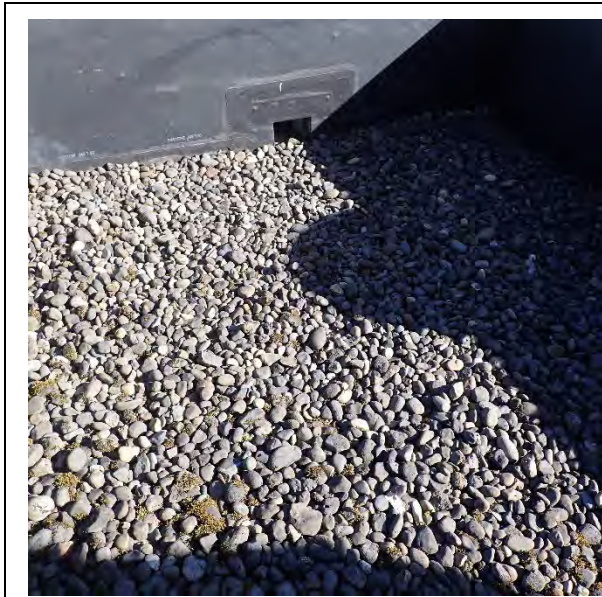
2.5 Gravel stops at scuppers are missing, allowing rocks to enter scupper and leader boxes and preventing proper drainage.
Location: Systemic throughout property

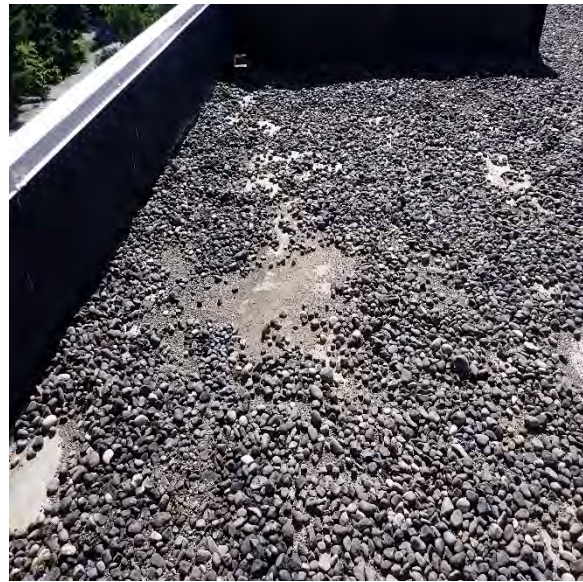
2.6 Gravel at EPDM roof is spread too thin, allowing the roof to be more exposed to UV and increasing the chance of the roof blow-off in these areas.
Location: Bldg. 4

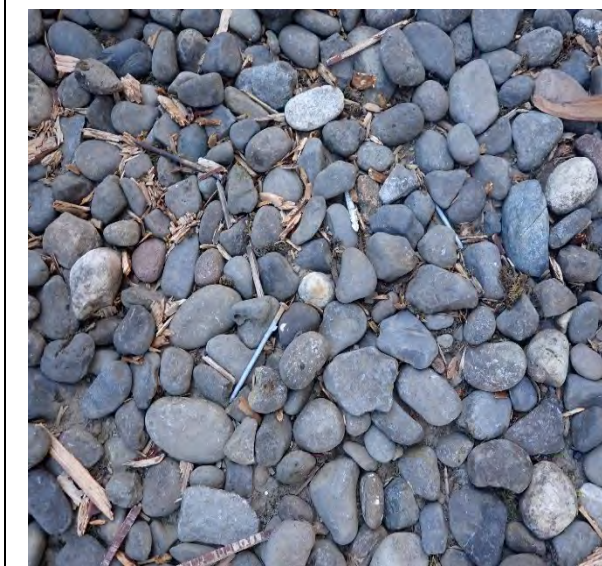
2.7A Debris from previous tile roof repair present at gravel areas of the EPDM roof. Drop clothes and plywood should be laid down over low slope roofs when tile repairs are made to protect the membrane from damage.
Location: Bldg. 2

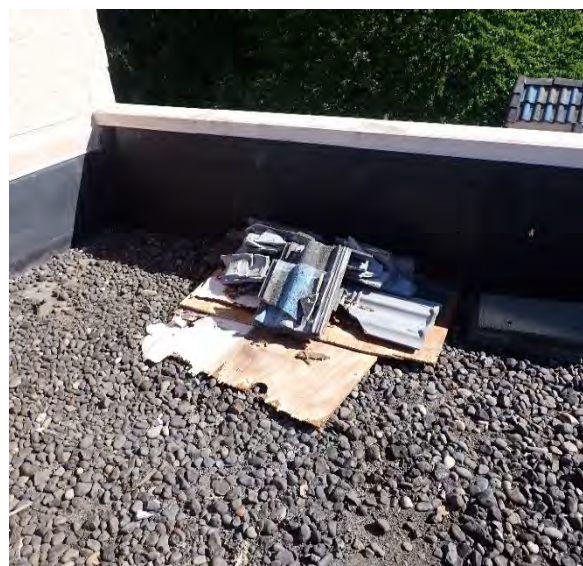
2.7B Additional example of debris from previous repairs present at EPDM roof.

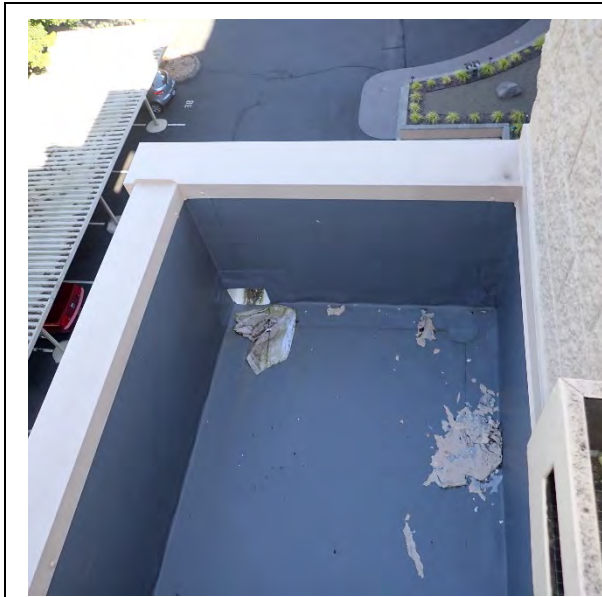
2.8 Debris and towels from previous painting work left on roof. Note proximity of debris to scupper. This could block proper drainage.
Location: Bldg. 1

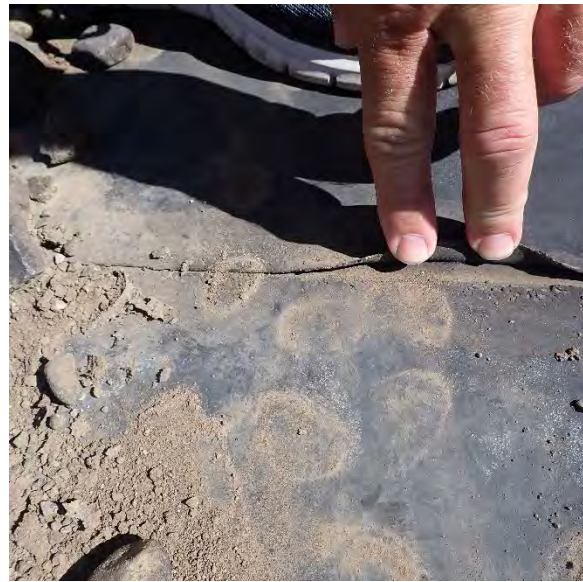
2.9A Seam at EPDM roof is lifting. All lifting or open seams should be repaired.
Location: Bldgs. 1, 3, 4

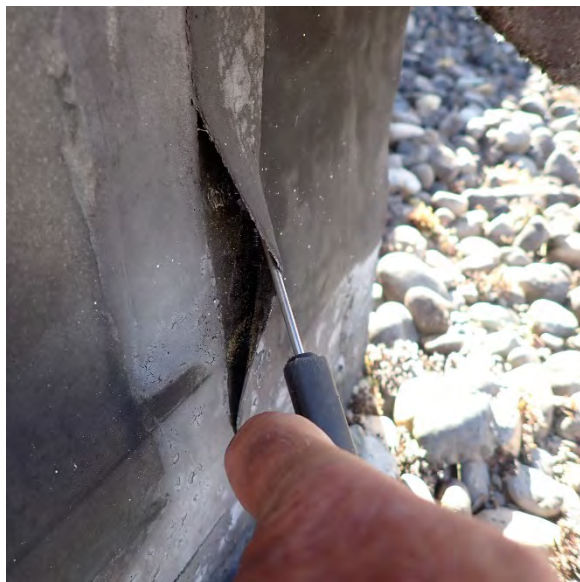
2.9B Additional example of lifting seam at EPDM roof.

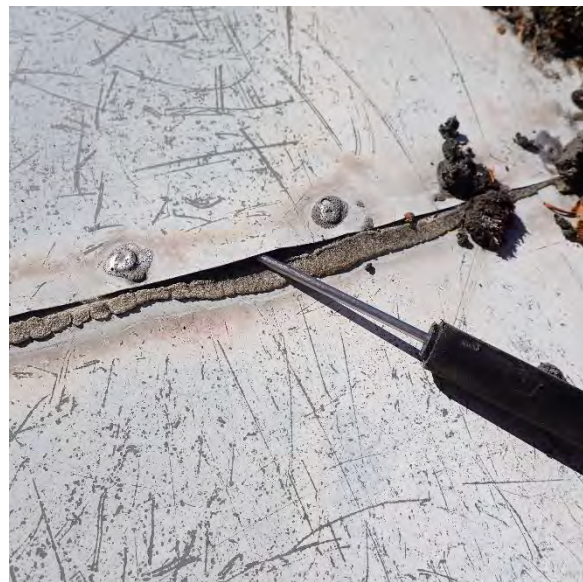
2.10 Open seam present at low slope metal valley roofs between tile roofs. All lifting or open seams should be repaired.
Location: Bldg. 1

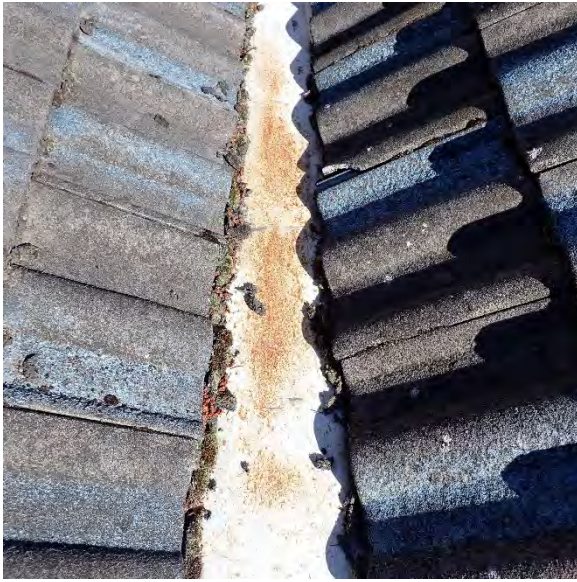
2.11 Low slope metal valley roof between tiles is corroded.
Location: Bldg. 1

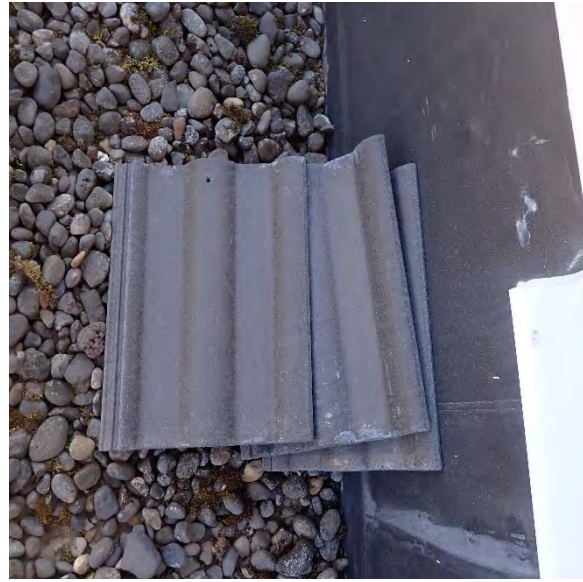
2.12 Extra tiles are being stored on roof. Tiles should be removed and stored in safe location.
Location: Systemic throughout property

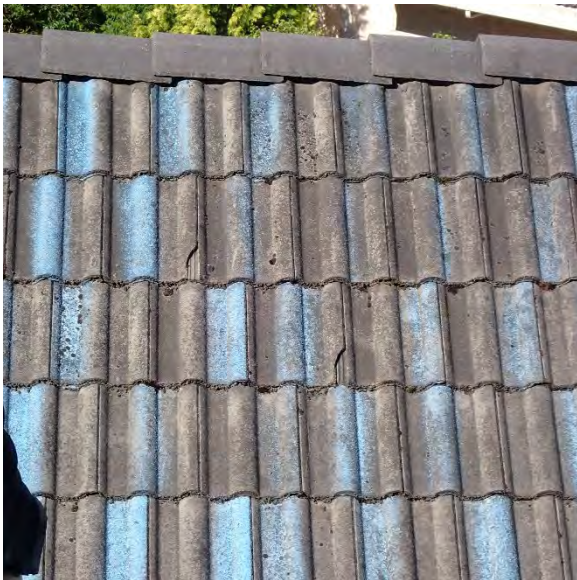
2.13A Lower corners of tiles are cracked and missing. Any tile with a crack over 3" should be replaced.
Location: Systemic throughout property

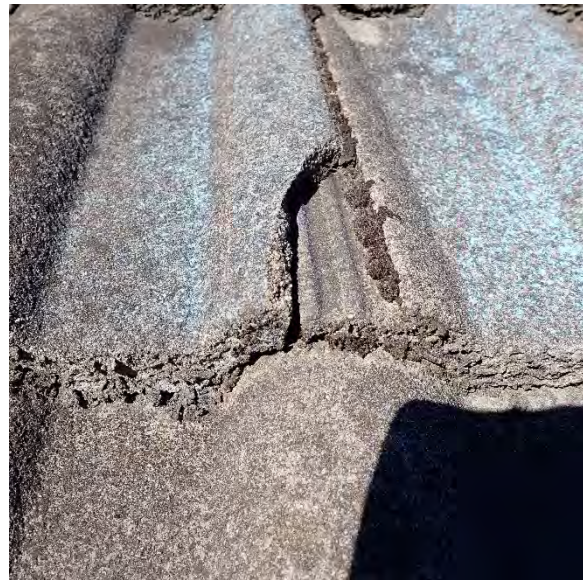
2.13B Closer view of damaged lower corner of tile.

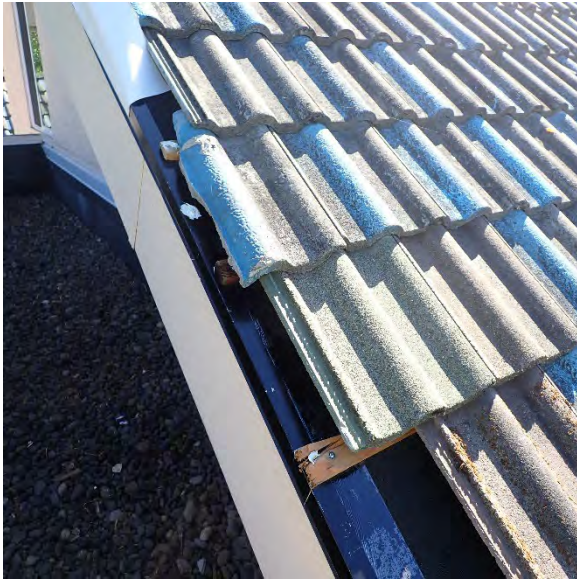
2.14A Tile is missing at rake edge of roof.
Location: Bldg. 2

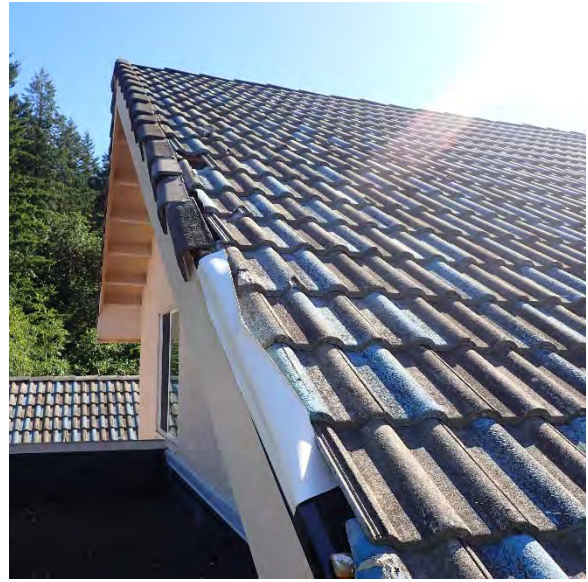
2.14B Additional view of missing tile at rake edge of roof.

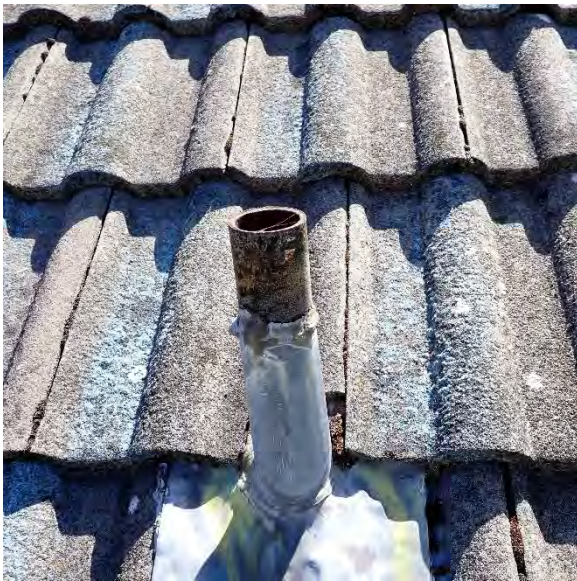
2.15 Lead cap at for pipe flashing is missing, allowing possible water ingress.
Location: Bldg. 5

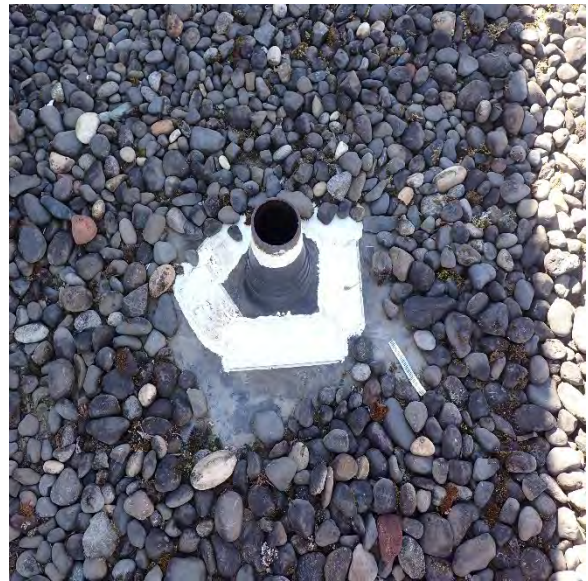
2.16A Pipe flashings on EPDM roofs have been previously repaired. Repairs to penetrations should be continued as needed until the roofs are replaced.
Location: Systemic throughout property

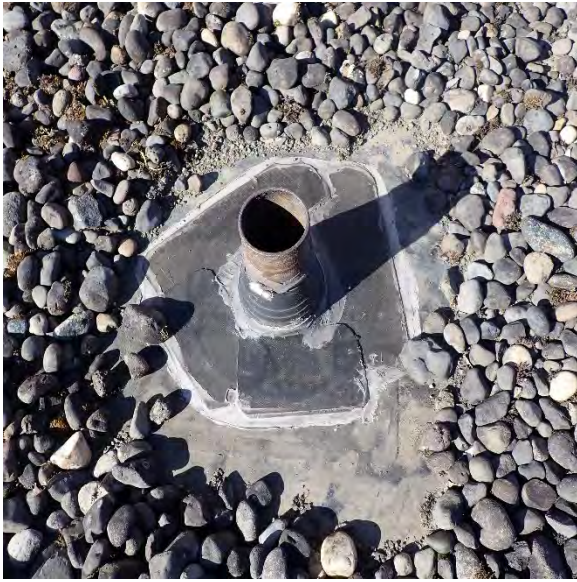
2.16B Additional example of previously repaired pipe flashing.

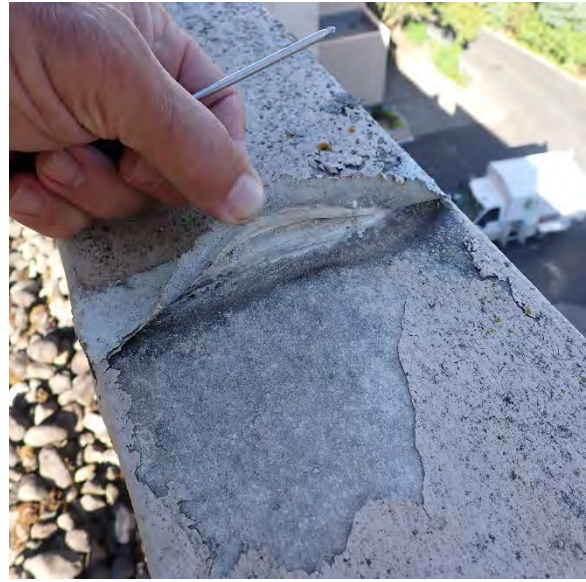
2.17 Sealant at coping metal joint is failing, and joint is lifting.
Location: Bldg. 1

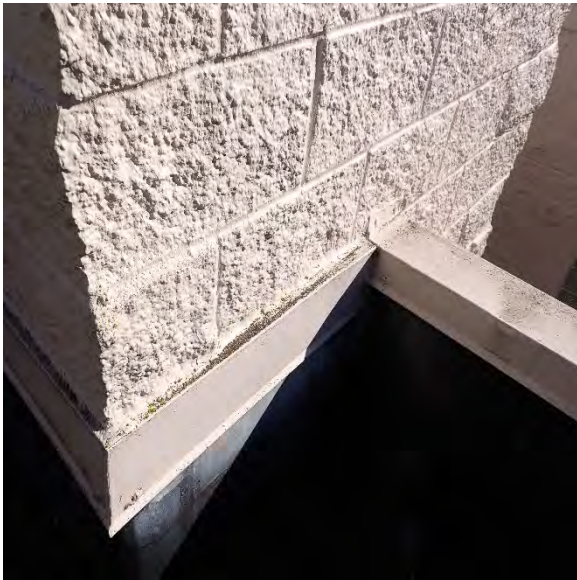
2.18A Surface mounted reglet and coping metal are sealant dependent at CMU wall and should be regularly maintained to ensure they remain sealed.
Location: Systemic throughout property

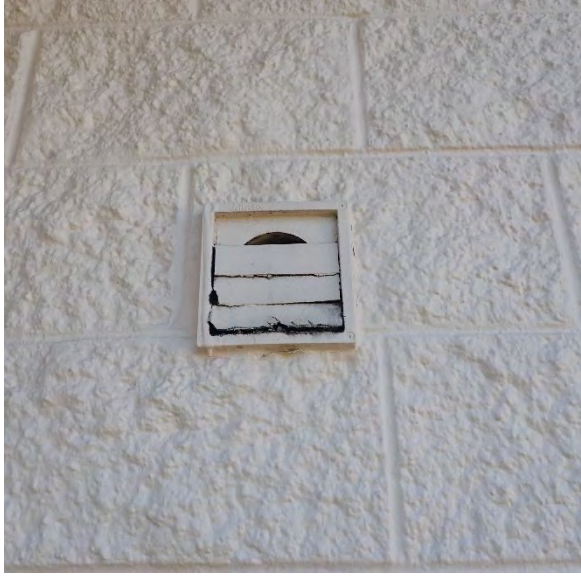
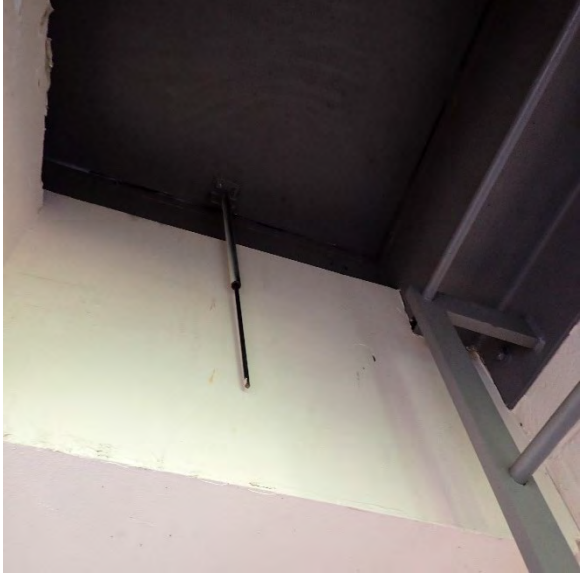
| <p>2.20 Louver is missing at exhaust vent, allowing possible water, animal, or pest ingress. Location: Systemic throughout property</p> | <p>2.21 Lifter shock at roof hatch is damaged and should be repaired. Due to damage, this hatch drops quickly, so anyone performing repairs should proceed with caution. Location: Bldg. 2</p> |

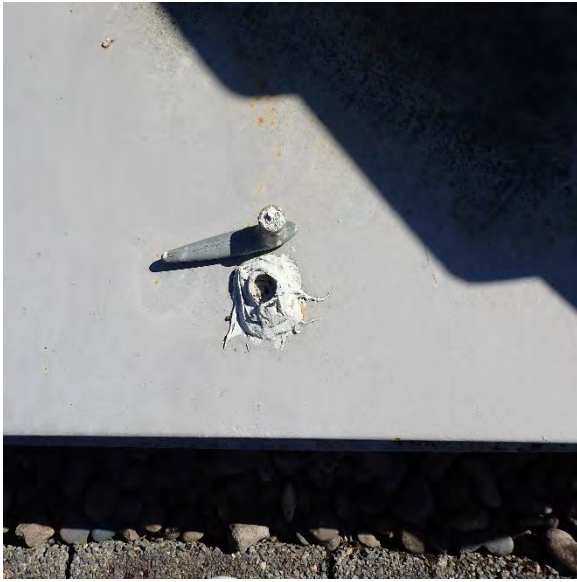
2.22A Handle at roof hatch is damaged and corroded, allowing possible water ingress.
Location: Bldgs. 2 & 5

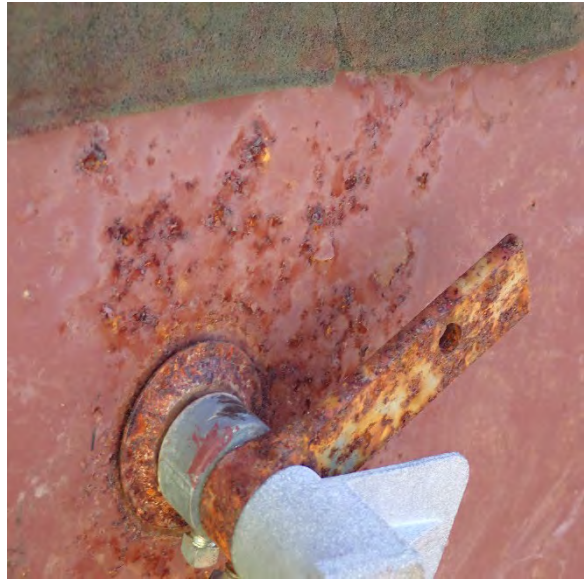
2.22B Additional example of damaged and corroded roof hatch handle.

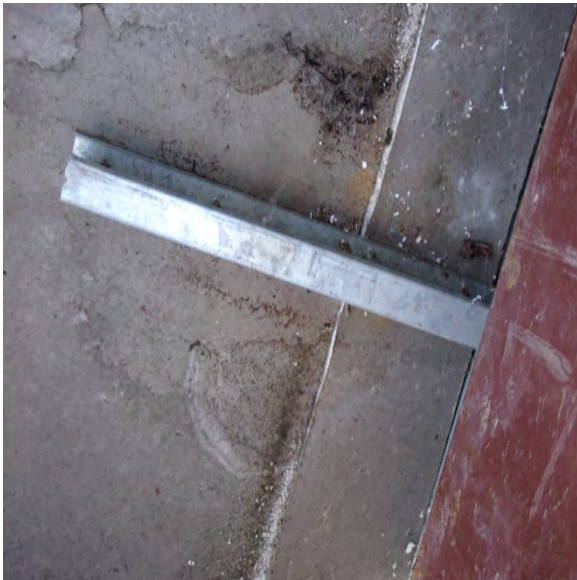
2.22C Water staining present on underside of roof hatch due to water intrusion at damaged handle.
