FROM **Shinji Coram**  
TOTAL PAGES 13**R-B4711.059**  
**Quintet**  
**Roof Replacement**

DATE November 21, 2022

REGARDING **Quintet Clubhouse Roof Replacement**

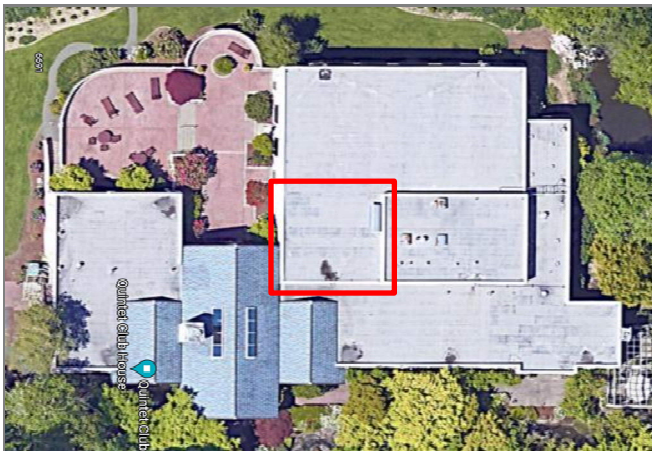
*Quintet Clubhouse Roof  
(Image from Google Maps)*

*Red box indicates known  
leak/damage area at exercise  
room.*

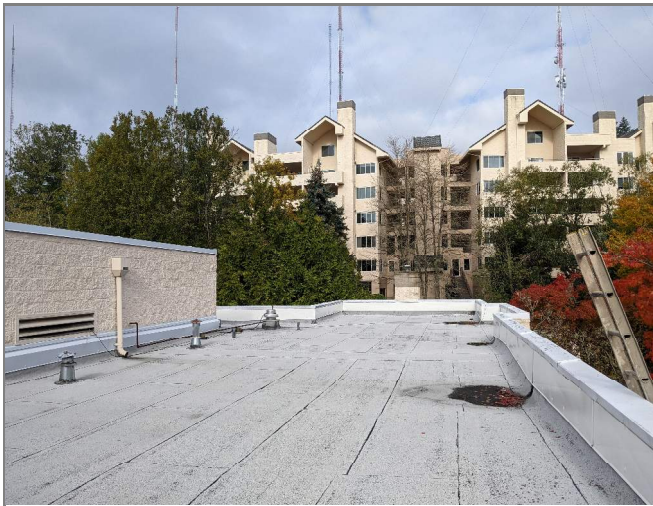
*Figure 1*

Generally, the roof appears to be ageing at an accelerated rate compared to what is typical for an approximately 13-year-old system. Loss of granules in the capsheet is systematic, exposing the black asphaltic component of the membrane. Additionally, we observe localized failed laps in the flashing membrane at parapet walls.

*Clubhouse roof, above property management office, conference room, and residence area.*

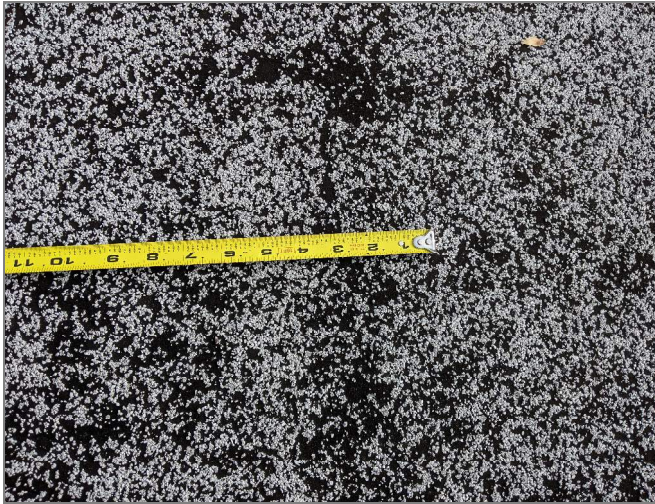
*Figure 2*

*Most significant area of granule loss*

A second major concern is granule loss, which exposes the asphaltic component of the membrane to ultraviolet (UV) degradation. Granule loss can be caused by a number of factors including material deficiencies, exposure to standing water, or excess movement in the material loosening the granules. Once the asphaltic component of the membrane is exposed to UV accelerated aging of the system can be expected. .

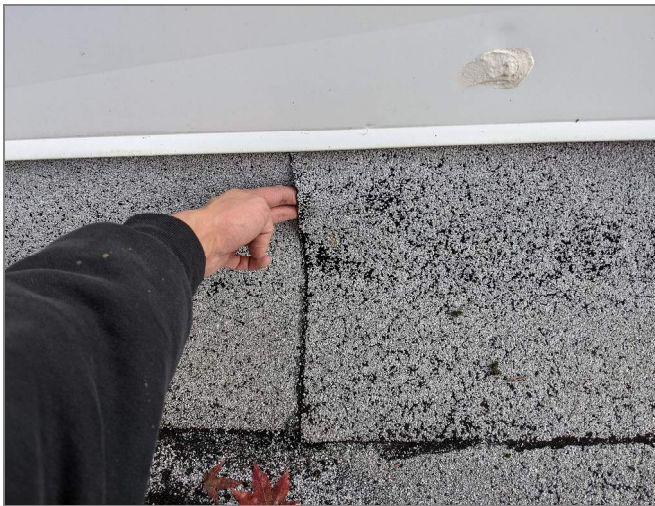
*Figure 3*

*Localized failure of flashing membrane laps.*

Open lap seams in the membrane system were also noted.

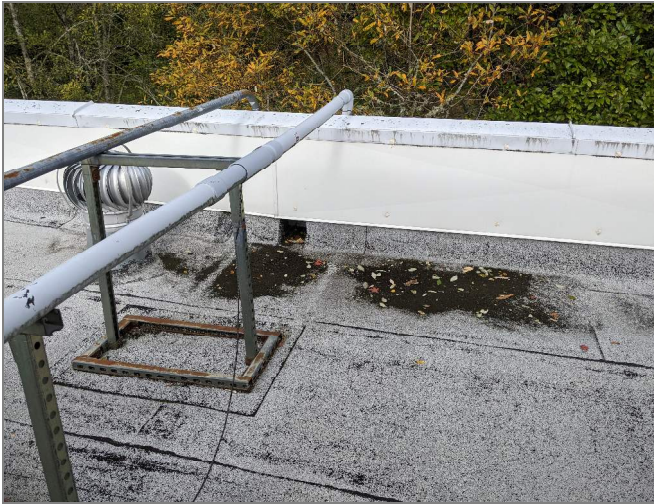
Figure 4

Primary drainage for the roof involves through-wall scuppers and collector boxes at each area. There are typically low spots in front of the scuppers, possibly relating to irregularities in the roof deck, where debris and water are accumulating. Scuppers generally show signs of repair with addition of mastic and granules. The mastic at repair areas shows signs of UV damage in the form of localized cracking and peeling.

Low spots in front of scupper. Note framing telegraphing through roofing.

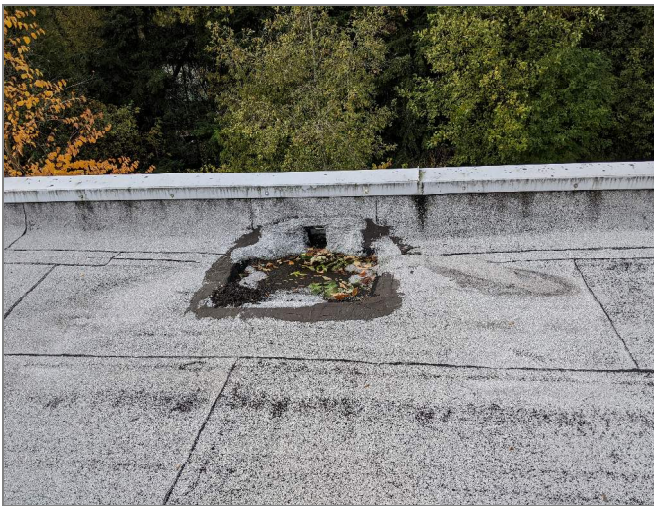
Figure 5

Scupper sump at pool hall roof.

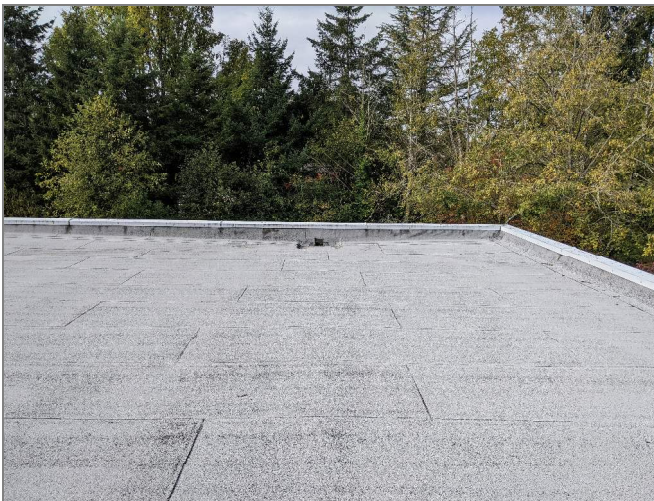
Figure 6

Additionally, at the pool hall roof, the roof deck appears to be bowing slightly in between structural beams. There is some apparent flex in the roofing at cricket valleys.

Apparent bowing or crowning of pool hall roof between glulam beams.

1. Apparent bowing or irregularity in the roof deck. The roof deck consists of structural plywood, of an unknown age. The plywood deck is installed over engineered wood joists at most areas, and in the pool is supported by dimensional lumber roof rafters. There may be a number of factors that could cause bowing of the sheathing including moisture damage over time, inadequate thickness, or inadequate support (in the pool area), To understand this condition, test cuts would be required to verify the roof deck sheathing thickness and overall condition. This condition should be verified prior to construction because it could result in additional cost during construction.

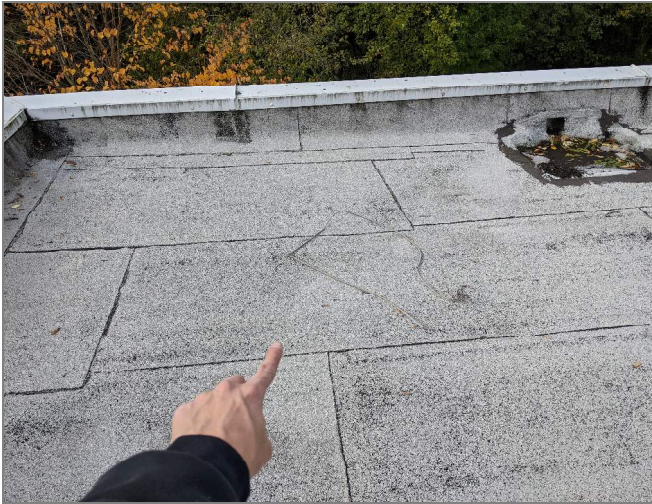
*Figure 7*

*Soft spot in roof apparent at cricket valley.*

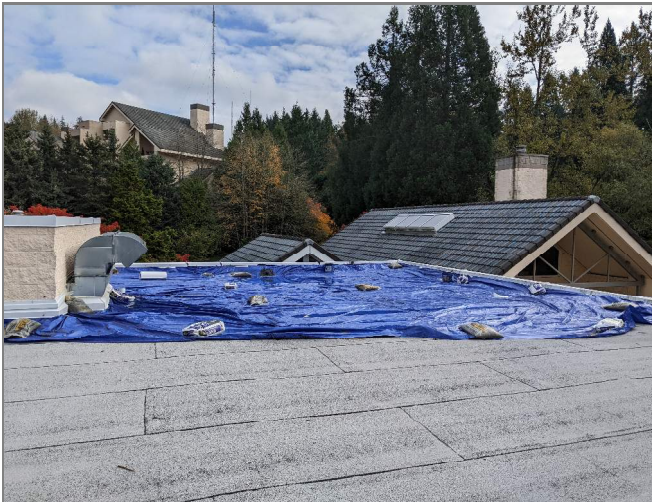
*Figure 8*

The exercise room roof, while a different assembly than the pool room roof, appears as a continuation of the pool room roof membrane, sloping the opposite direction from the ridge. The previous repair area at the exercise room roof has been covered with additional sheeting, which is sealed to the roof surface with mastic. We anticipate that this is either a remedial or proactive measure from the roofer to protect the damaged roof deck below. Ponding water on the tarping reveals lack of slope in the roof area, which may contribute to the leaks and damage previously observed.

*Tarped off area above exercise room roof.*

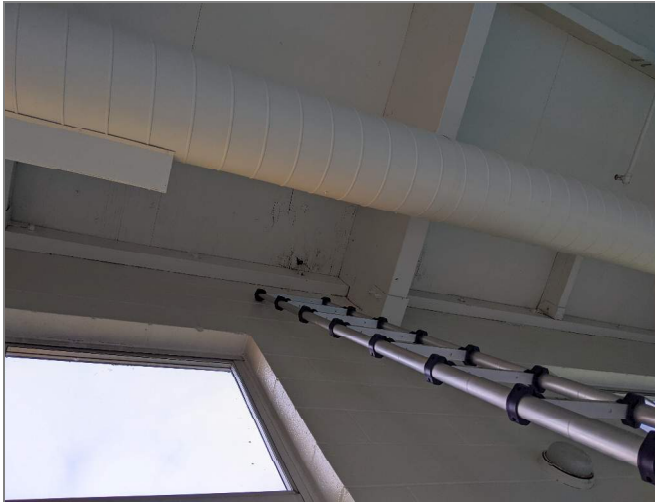
*Figure 9*

*Known leak and damage area at pool hall roof.*

There appears to be a problem relating to the through-wall scuppers. In viewing the Pono photographs in the area of repair, the damage at the plywood deck appears to be concentrated at the valley leading towards the scupper. At the pool room, previous leaking was reported to us at the south side scupper, where peeling paint on the underside of the plywood deck is apparent. Moisture probe measurements inside the pool

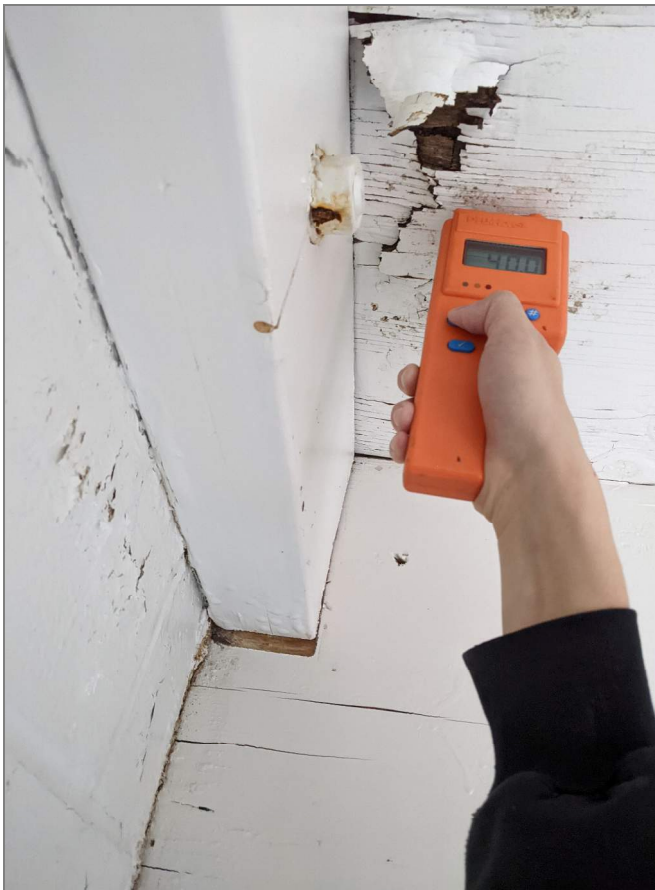
*Figure 10*

From the interior, we reviewed the sheathing condition at the pool hall roof. At the areas near the through-wall scuppers, we observed damaged paint and plywood, and recorded high moisture in the plywood.

*Damaged and wet plywood deck at pool hall roof.*

room, at the underside of the plywood at this area indicate a local Moisture Content (MC%) of 40, which is the maximum reading of the probe and indicates the wood is wet. The immediately surrounding area reads a %MC of 13-22 %MC indicating elevated risk of moisture damage. Measurement of the north side scupper, which was not reported to leak but shows signs of peeling paint, reveals similar findings of 20-40 %MC readings. %MC readings taken at areas away from the scuppers at the roof ridge and crickets indicate a typical %MC of 7-11 %MC, revealing the scupper areas to be an anomaly and likely associated with a leak. Based on the number and condition of repairs apparent at the scuppers, we anticipate that leakage from the scuppers have contributed to damage at the pool hall roof, and at least localized replacement of insulation and roof deck will be necessary.

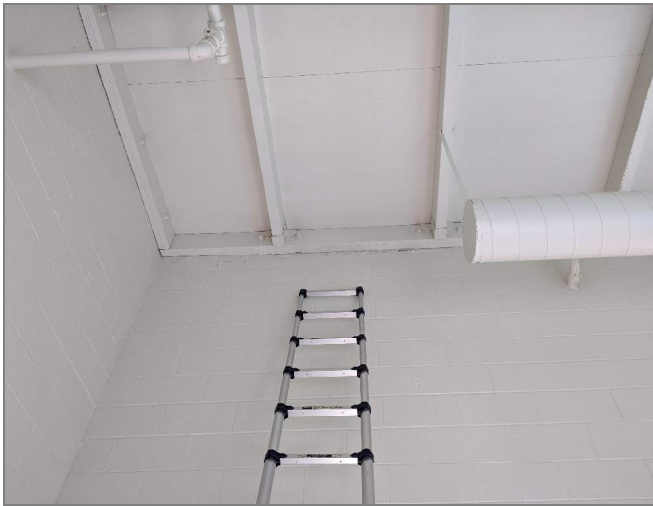
Figure 11

Additionally at the pool room, we observed staining and peeling paint on the glulam beams and adjacent CMU walls which may indicate a history of condensation.

*Peeling paint at wood beams and CMU block.*

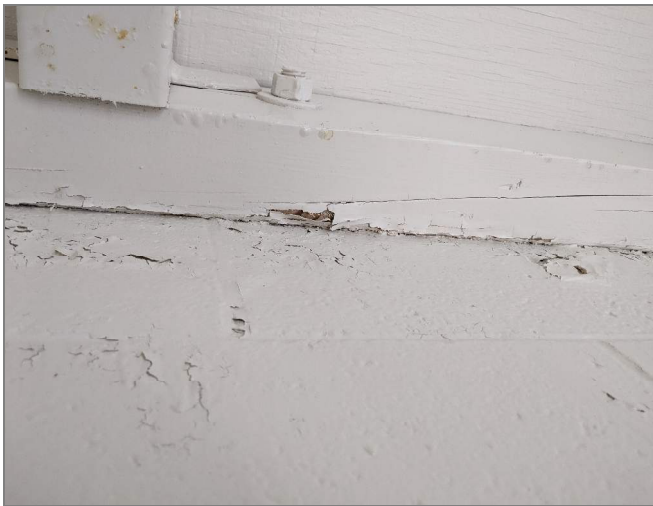
Figure 12

*Apparent history of condensation, potential leakage.*

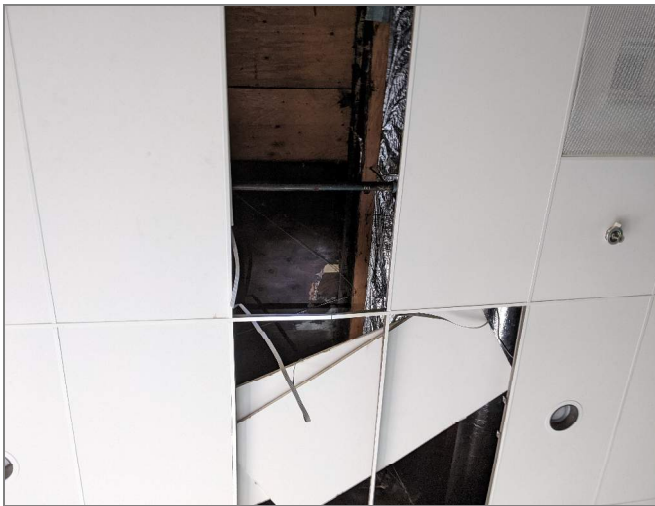
Figure 14  
Damaged plywood area at

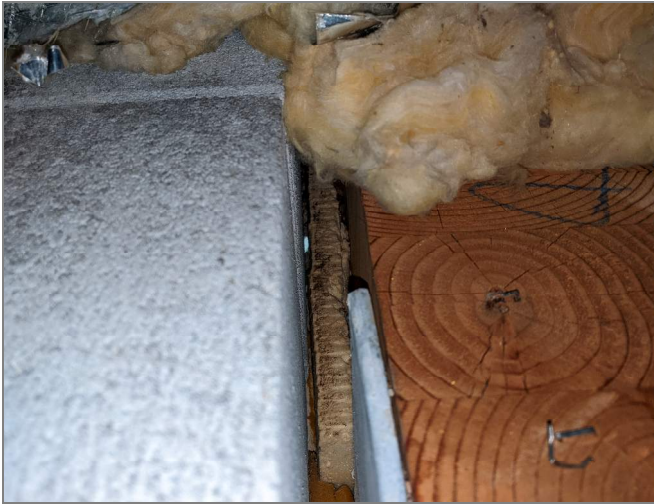
Figure 16

Wood components generally appear to be in sound condition, with the exception of the leak damaged area. Surface corrosion on metallic elements such as bolts indicate a history of high moisture in the environment. Foam is packed between the CMU and the Glulam beams, but is not fully sealed and allows for high moisture air from the pool room to enter the crawlspace.

*Not sealed between CMU and Glulam, allowing for high moisture air to enter the crawlspace.*

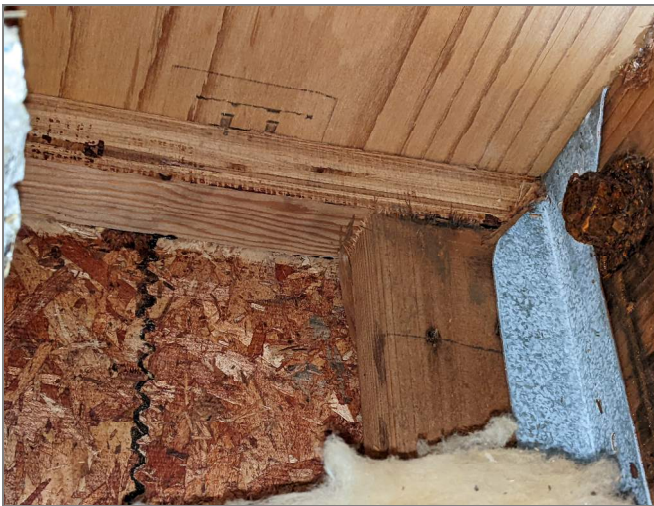
Figure 17

*TJI's and plywood deck appear in sound condition, corrosion on structural bolts.*

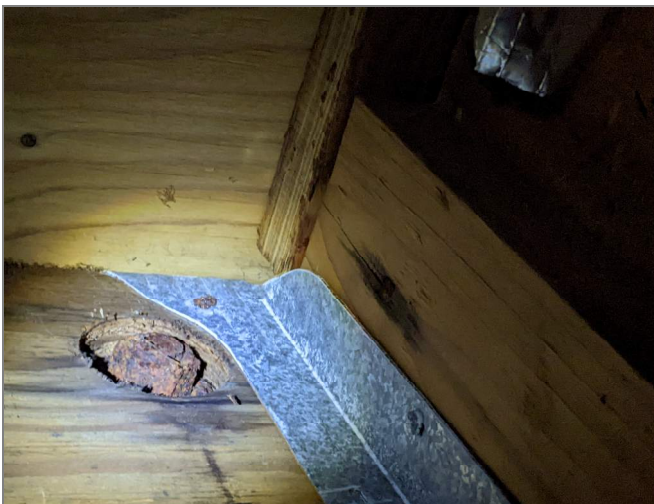
Figure 18

*Corrosion on structural bolts indicating high moisture environment.*

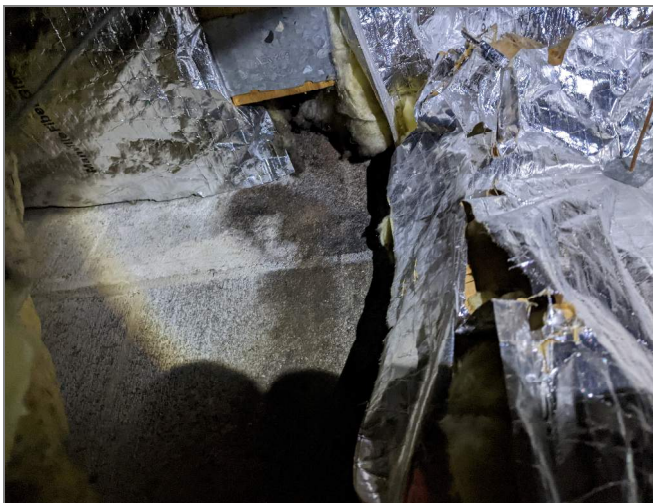
*Figure 20*

We also accessed the conference room on the east side of the building but were unable to directly observe the roof deck. Staining at the CMU wall may indicate a history of moisture retention or air movement in the crawlspace above the drop ceiling.

*Staining at CMU indicates history of moisture in crawlspace.*
