To Jimmy Songvilay  
Kin Living  
139 SE Taylor Street, Suite 200  
Portland OR 97214

Revised March 14, 2022 by  
RDH Building Science Inc.  
5331 SW Macadam Avenue #314  
Portland OR 97239

RDH Building Science Inc. (RDH) was retained by Kin Living to undertake an assessment of the current condition of the building enclosure of the buildings at the Quintet Condominiums complex located at 6695 W. Burnside Road, Portland, OR.

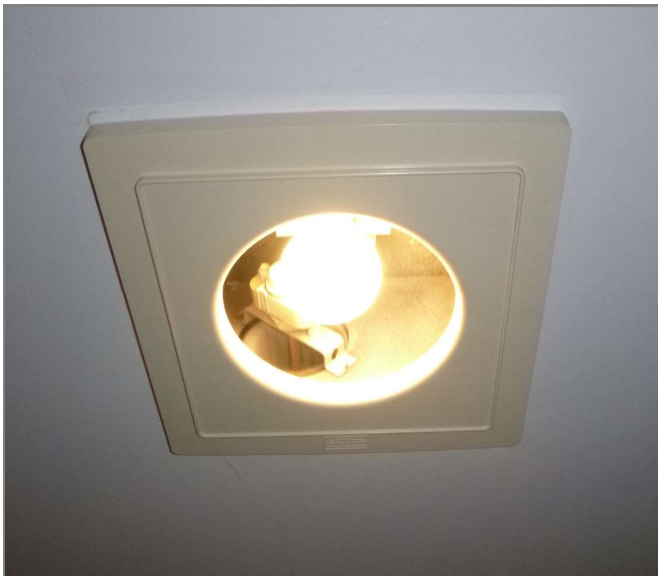
*Figure 3.2  
Typical original bathroom fan unit with bulb heater*

We also recommend that the residents replace old bathroom and laundry exhaust fans with a new, quiet operation, high volume fans. Fans that are not operational should be repaired or replaced. Residents should also inspect their range hoods while in operation and feel for any air leaks at the exhaust pipe above the hood. Range hoods with low air intake or leaks in the exhaust should be repaired or replaced.

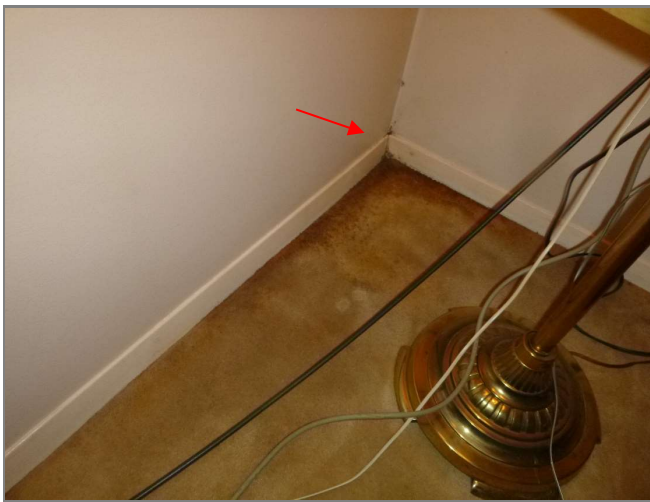
- Elevated moisture content (0.3 - 0.7%) of gypsum wallboard adjacent to windows and at the NW corner of Unit 111 indicating potential water ingress.
- Damp surfaces and elevated moisture content at SW corner of Unit 524 adjacent to replaced glass blocks indicating potential water ingress.

*Figure 3.4  
Unit 111  
Elevated moisture content and  
potential organic growth at  
NW corner of second bedroom.*

RECOMMENDATIONS	
<b>1</b>	<i>Deficiency:</i> Investigate potential leaks at Unit 111 and 524 causing surface wetting and elevated moisture content in interior finishes.
<b>2</b>	<i>Deficiency:</i> Investigate major humidity/moisture concerns at Units 126, 243, 333, 427, and 520.
<b>3</b>	<i>Deficiency:</i> Investigate popping sound occurring at Building 2.
<b>4</b>	<i>Maintenance:</i> Engage qualified personnel to inspect mechanical systems and fireplaces at regular intervals at all units.
<b>5</b>	<i>Maintenance:</i> Distribute a memo providing residents and owners with guidelines for managing interior humidity

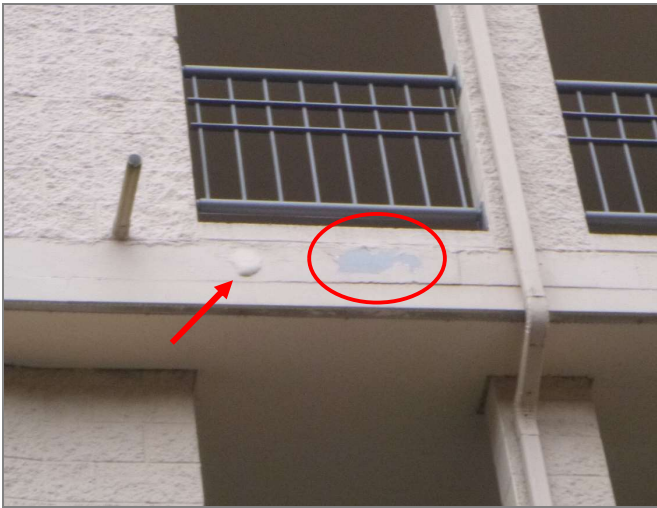
*Figure 3.6*  
*Building 3*  
*Peeled and blistering coating*

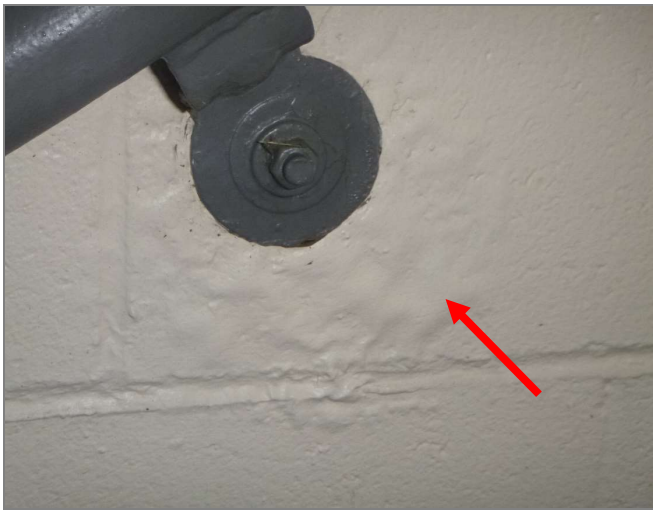
*Figure 3.8*  
*Building 1*  
*Blistering coating at open-air*  
*corridor stairwell*

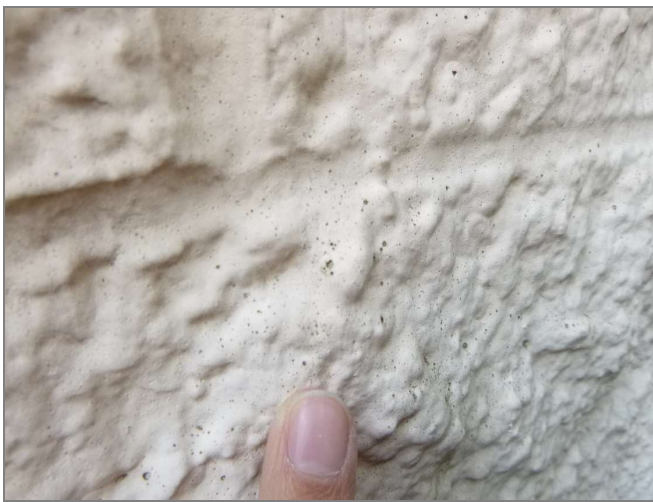
*Figure 3.9*  
*Clubhouse*  
*UV degradation resulting in*  
*pinholes in coating.*

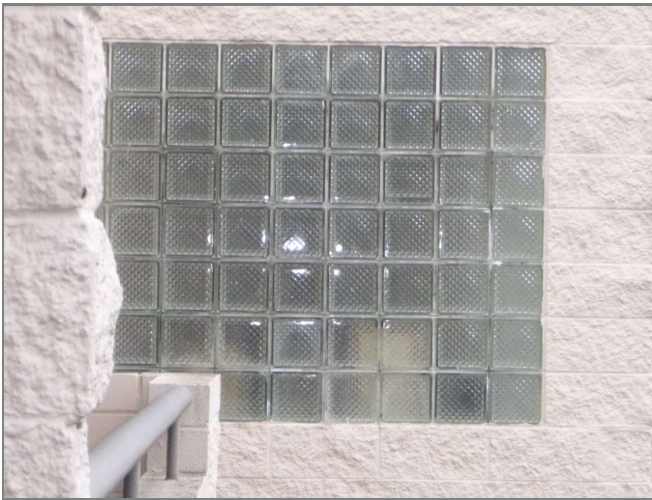
We observed instances of cracked and fogging glass at areas not yet replaced. We are not aware of significant cracked glass or leakage at the areas with new glass blocks. However, the glass blocks have a limited life expectancy and have poor thermal resistance. We recommend considering replacing the glass block areas with windows with insulated glazing units in the future.

*Figure 3.19  
Adjacent to Unit 456  
Fogging present in glass  
blocks.*

RECOMMENDATION	
13	<i>Maintenance:</i> Continue glass block replacement program and monitor for additional and premature glass breakage or leaks.
14	<i>Improvement:</i> Consider replacing glass block areas with thermally broken windows with insulated glazing units.

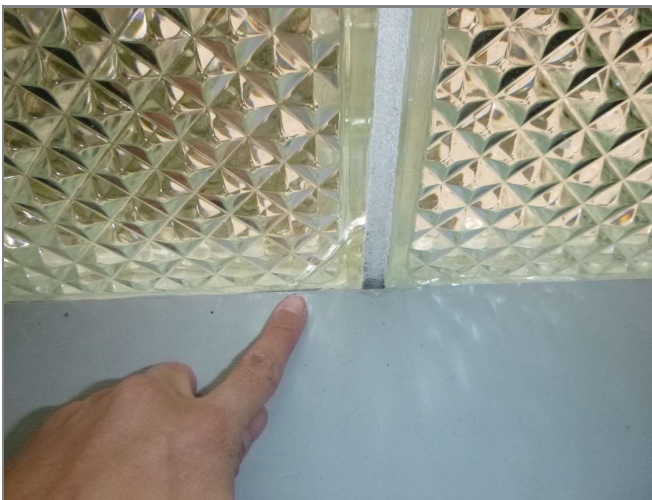
*Figure 3.20  
Unit 327  
Minor cracks present at glass  
blocks*

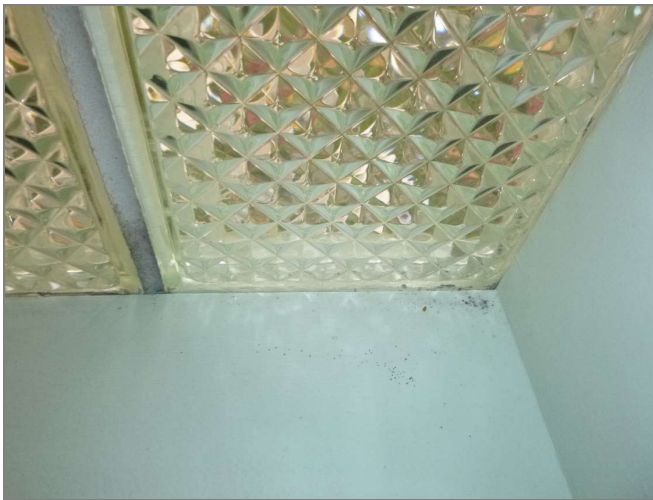
Figure 3.21  
Unit 340  
Localized black organic growth at mortar and windows, indicating ongoing condensation issues.

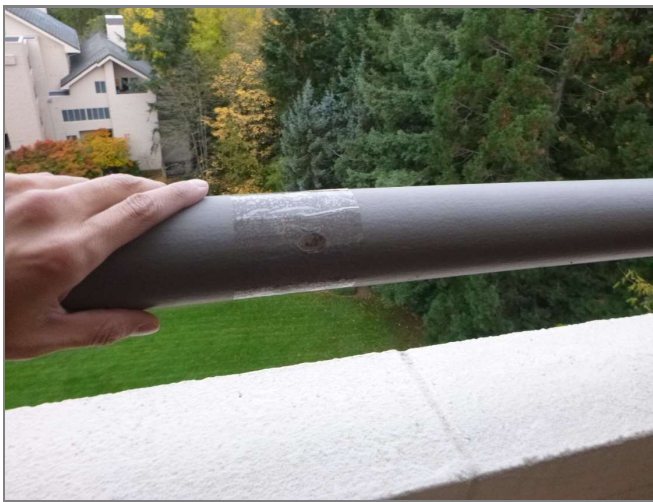
Figure 3.24  
Unit 456  
Worn handrail coating. Tape added by Owner.

Railings should be remediated and repainted on a regular basis. We recommend conducting this work concurrently with the next concrete resealing event. Railing surfaces should be prepared according to paint manufacturer specifications and painted with a direct-to-metal paint designed for exposure.

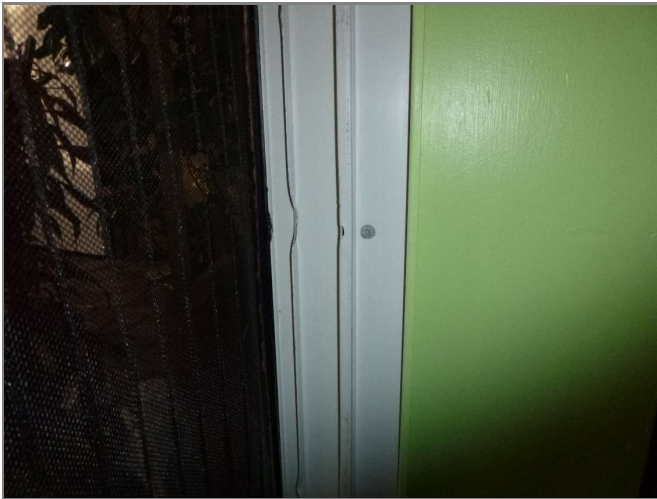
Figure 3.37  
Unit 216  
Damage to aluminum frame  
and door gasket.

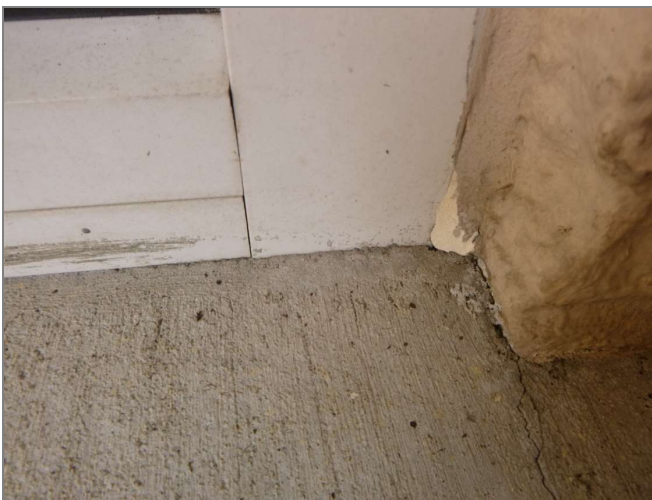
corners. At most areas, the sidewalk/hardscape is covering the bottom edge of the storefront frame.

*Figure 3.47  
Clubhouse west elevation  
Hardscape covers bottom edge  
of storefront system.*

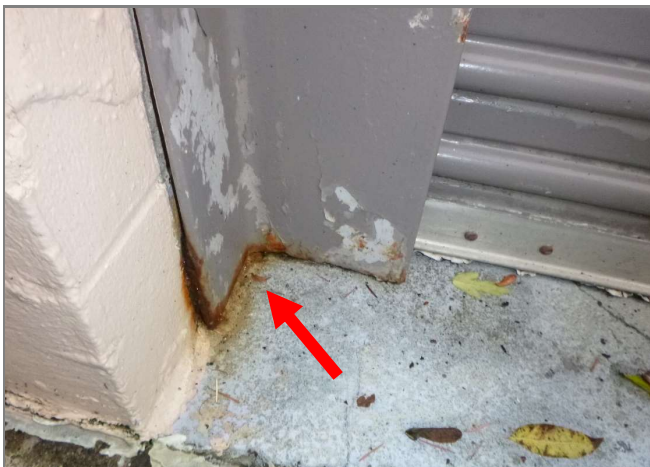
Overhead coiling doors are present at the ends of each building facing the plaza at the trash receptacles. Paint is failing at the edges of some overhead rolling door frames near the ground, leading to surface corrosion.

*Figure 3.57  
Building 1  
Corrosion at coiling door frame.*

RECOMMENDATION	
<b>27</b>	<i>Maintenance:</i> Remediate surface corrosion and remove failed paint. Repaint coiling doors and frames with a durable direct-to-metal paint.

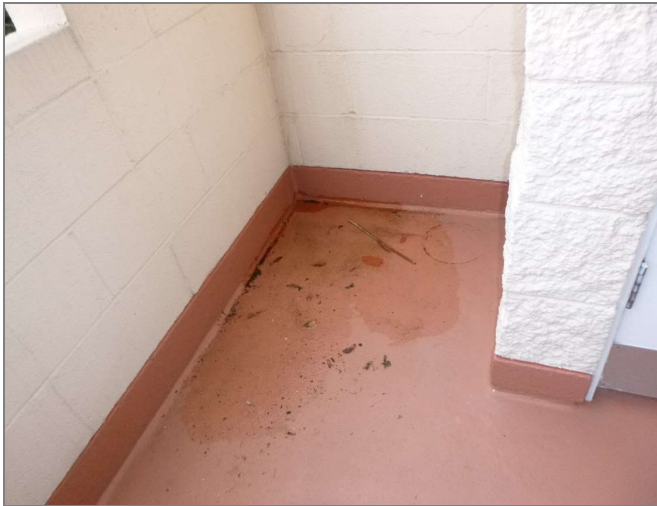
*Figure 3.61*  
*Unit 456*  
*Standing water at balcony*  
*corner with no scupper*

- Areas of poor drainage and standing water are common at the exterior corners of the balconies.
- Most balconies have two PVC pipe drains—one at each corner. However, some units only have one drain for the whole balcony. These scuppers are relatively small (<3”) in diameter and are easily obstructed.

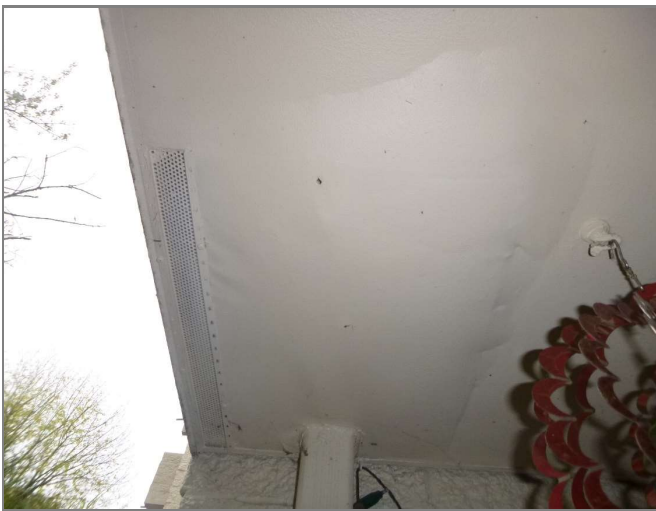
*Figure 3.65  
Unit 111  
Large blister in coating at vented soffit with downspout penetration*

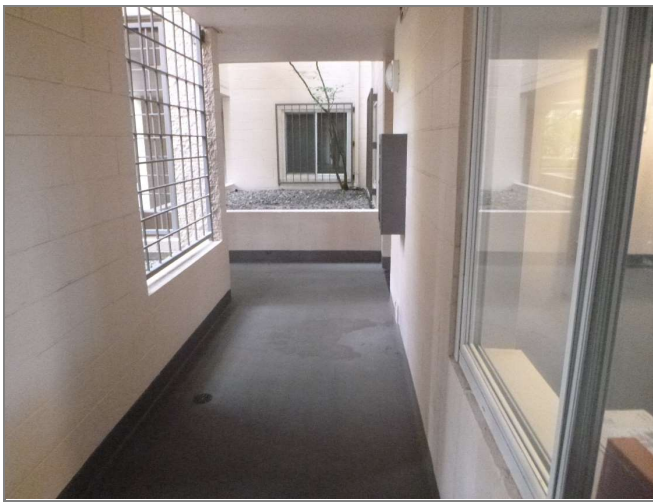
*Figure 3.66  
Building 5  
Typical ground floor open-air  
corridor.*

- Ground floor corridors tend to be less exposed to weather compared to upper levels due to bordering larger shear walls and the presence of the enclosed elevator lobby. However, this also means water that does penetrate the ground-floor corridor space is less likely to dry in the sunlight.

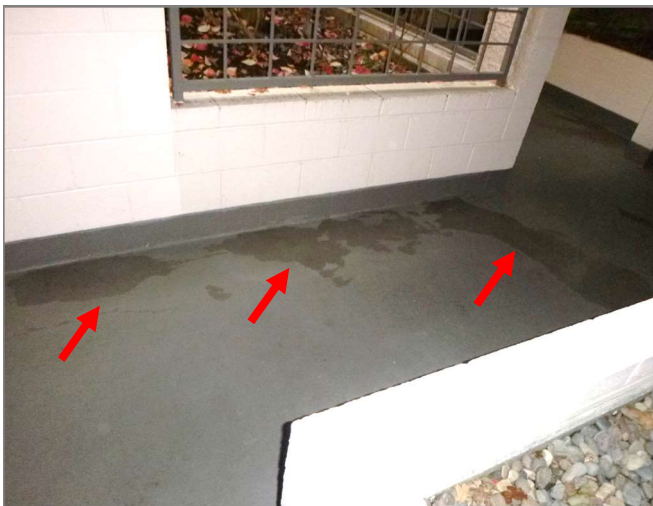
*Figure 3.67  
Building 5  
Lack of slope resulting in poor  
drainage*

- Standing water is observed as an issue adjacent to lightwell planters, which collect the water runoff from the walls above.
- The ground floor is level with the exterior grade, allowing water to occasionally enter from the egress doors. See Figure 3.53 above.

Standing water at the corridor leads to unsightly ponding and staining, and can be a potential safety hazard. Over time, standing water can lead to degradation of the coating and concrete, leading to leaks. However, this is a systematic design issue that is not easily fixed. The corridor surface can be locally re-sloped to direct water away from corners, but does not address the amount of water penetrating the corridor space. Overhangs or glazing panels at the corridor openings can reduce the amount of water that penetrates the corridor space, especially at the higher exposure elevations facing away from the plazas, which are at the high side of the corridor space.

We recommend a combined approach to locally re-slope the corridor surface and provide overhang flashings to manage standing water and reduce the moisture load. It should be

RECOMMENDATION	
31	<i>Deficiency:</i> Repair localized damage to corridor soffits. Provide moisture-resistant gypsum board.
32	<i>Improvement:</i> Recommended to recoat corridor spaces with a urethane pedestrian traffic coating.
33	<i>Improvement:</i> Replace scupper openings with sheet metal scuppers concurrently with recoating work.
34	<i>Deficiency:</i> Locally re-slope corridor concurrently with recoating work to direct water away from walls and walking areas.
35	<i>Improvement:</i> Provide overhangs at corridor openings, especially at the high exposure elevations facing away from plazas.
36	<i>Improvement:</i> Provide drip edges at soffits.

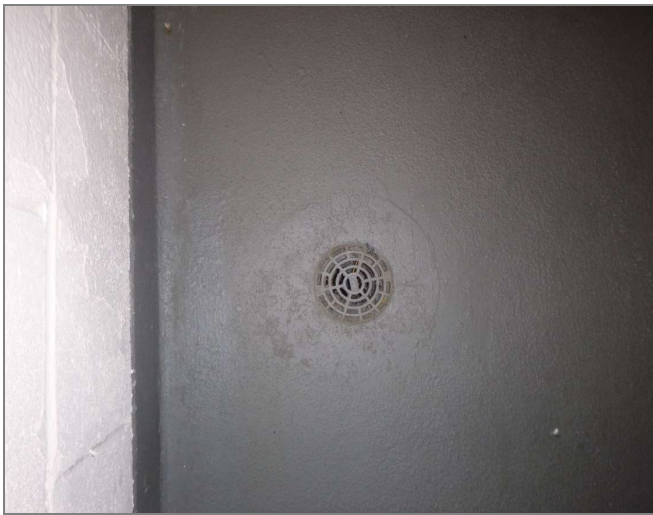
*Figure 3.68  
Building 5  
Typical floor drain.*

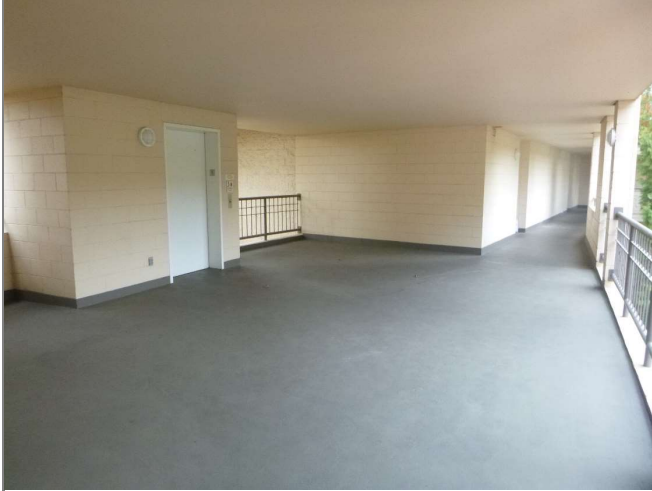
Figure 3.70  
Building 5  
Typical open-air corridor at elevator lobby.

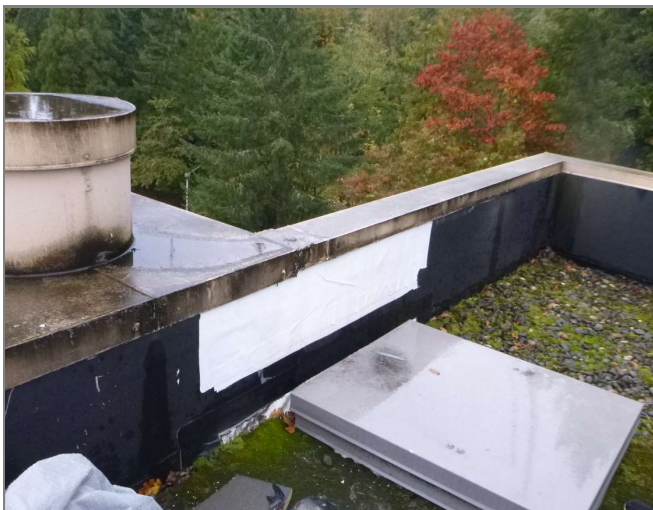
Figure 3.77  
Building 5  
Temporary patch of self-adhesive material.

- The EPDM membrane is cracking and scaling.
- The roofing membrane is patched in several locations.
- The sealed joint at membrane transitions is failed in some locations.
- At the roof membrane termination bar, gum lip sealant is in poor condition.

The expected service life of a ballasted EPDM roof ranges from 15 to 20 years. The low-slope roofs at the residential buildings were originally installed in 1990 and 1991, making them 30 to 31 years old. The roofs are showing signs of deterioration associated with their age. With increased roof age comes an increased risk of leaks, which can cause significant damage to interior living spaces and the soffits of the open-air corridors. Debris build-up and poor slope can lead to the ponding water that is present on the roof, which in turn can increase the likelihood and severity of leaks.

The Quintet low-slope residential roofs have reached the end of their service life in terms of both expected age and current physical condition.

We understand that the Association currently plans to begin re-roofing activities starting in 2022 and that the program will last eight years. This generally aligns with our recommendation that the roofs be replaced within approximately 5 years. The existing roofing should be carefully monitored for leaks and additional damage until its replacement. We recommend replacing the ballasted EPDM system with a more robust roofing system that will provide a 30-year service life such as a two-ply SBS modified-bitumen (asphalt) roofing system, similar to the roof installed on the clubhouse low-slope roof. The two plies of modified bitumen sheet are generally cold-adhered or torch-applied, and provide an added layer of protection as compared to single-ply systems, such as EPDM, PVC, or TPO membranes. Re-roofing also provides the opportunity to install additional roof insulation, if desired.

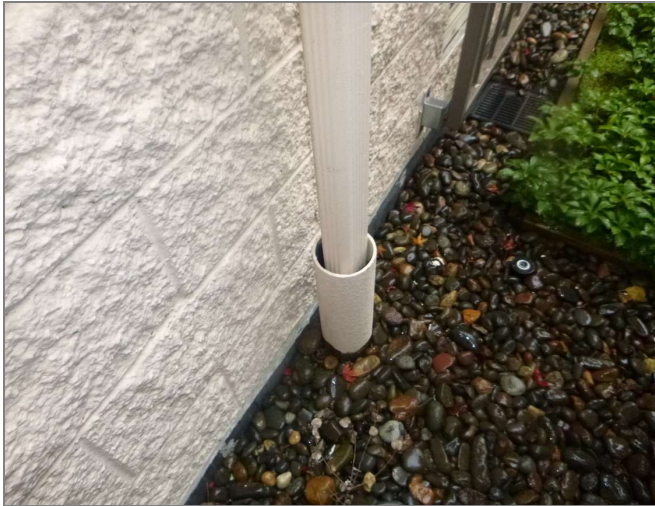
→ The downspout cross-sectional tube dimensions are approximately 3 inches by 2 and 1/4 inches. This size of downspout is likely too small for the total capacity requirements of buildings the height and size of those at the Quintet.

*Figure 3.89  
Building 1  
Downspout drains into PVC pipe that extends below raised planter*

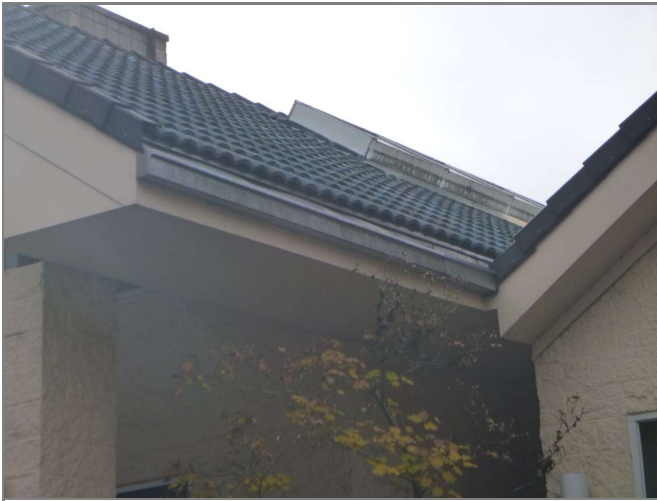
*Figure 3.97  
Clubhouse  
Gutter along main gabled roof  
at the entry does not appear  
to have any means to drain.*

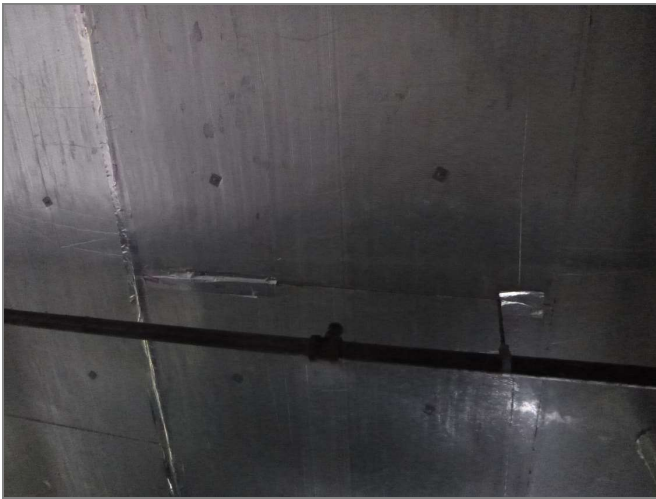
*Figure 3.105*  
*Building 1*  
*Foil-faced insulation boards*  
*applied to underside of*  
*conditioned space. Foil tape is*  
*discontinuous.*

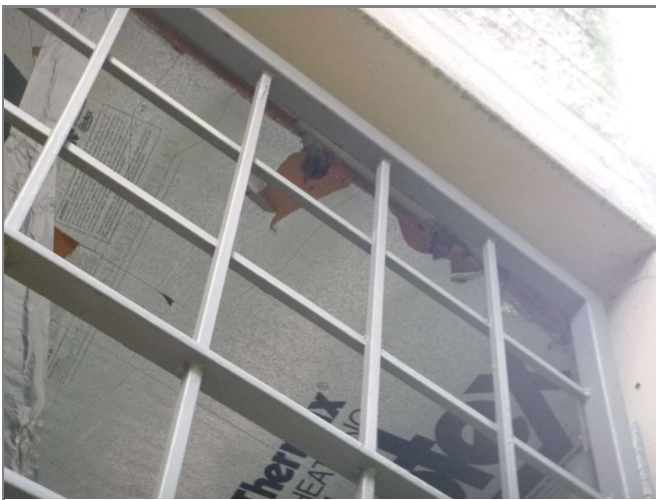
*Figure 3.106*  
*Building 4*  
*Discontinuous and damaged*  
*insulation board at edge of*  
*parking garage.*

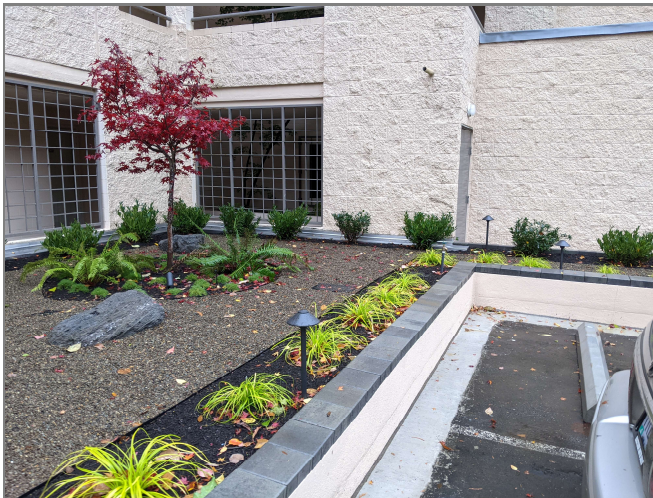
*Figure 3.109  
Building 1  
Renewed planter with coated  
CIP concrete wall*

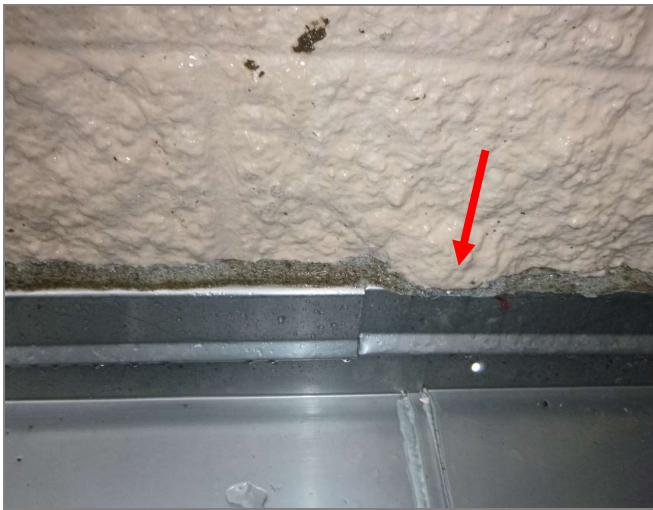
While the coating system as reported to us appears to be sound, some discontinuities and vulnerabilities in the perimeter flashing do exist, as outlined below.

Figure 3.110  
Building 1  
Inconsistent sealant fillet bead  
width at new counterflashing.

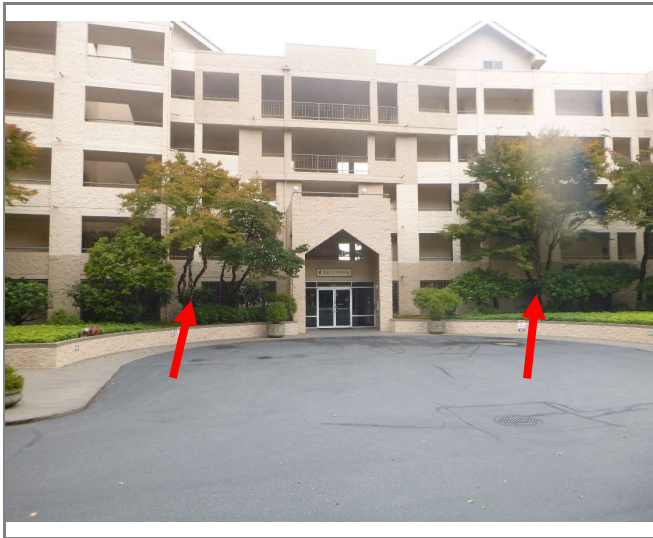
*Figure 3.113  
Building 4  
Large established trees  
growing in center front  
planters*

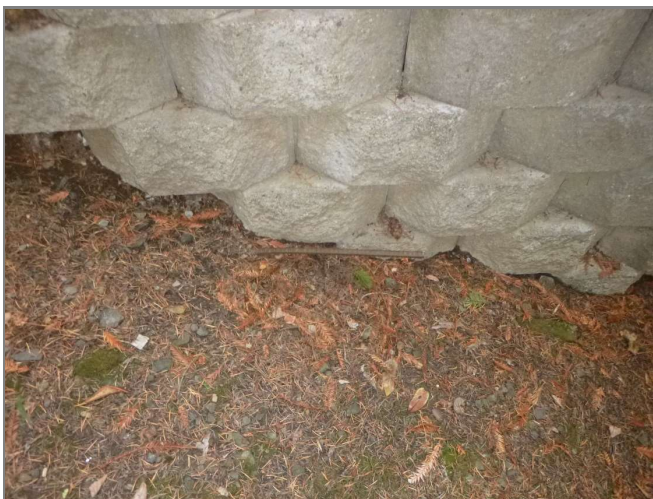
*Figure 3.116  
Building 4  
Exposed rebar at retaining  
wall.*
