FROM **Shinji Coram**  
TOTAL PAGES 13**R-B4711.059**  
**Quintet**  
**Roof Replacement**

DATE November 21, 2022

REGARDING **Quintet Clubhouse Roof Replacement**

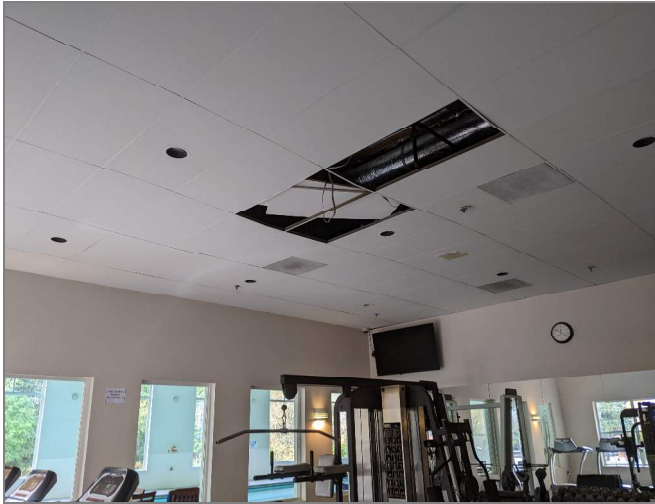
Figure 13  
Drop ceiling at exercise room.

The exercise room has a drop ceiling assembly forming a crawlspace between the interior and the roof assembly. We reviewed the condition of the sheathing and TJIs in the roof assembly above the drop ceiling. We also reviewed the CMU wall, which separates the pool room and exercise room, and serves as the bearing point for the Glulam beams in the pool room.

Wood components generally appear to be in sound condition, with the exception of the leak damaged area. Surface corrosion on metallic elements such as bolts indicate a history of high moisture in the environment. Foam is packed between the CMU and the Glulam beams, but is not fully sealed and allows for high moisture air from the pool room to enter the crawlspace.

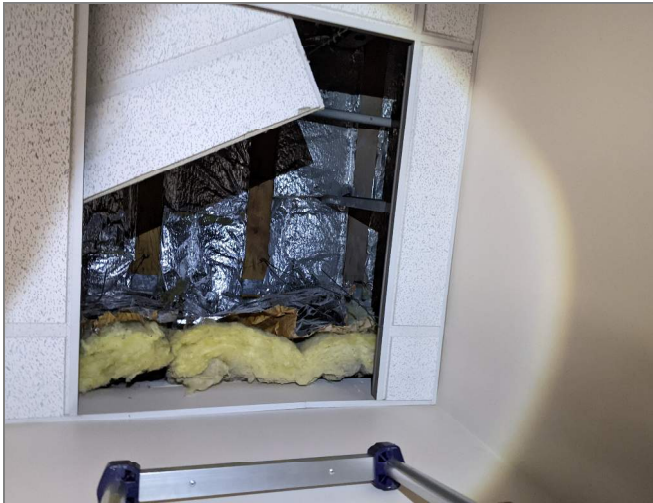
*Figure 19*

We also accessed the conference room on the east side of the building but were unable to directly observe the roof deck. Staining at the CMU wall may indicate a history of moisture retention or air movement in the crawlspace above the drop ceiling.

*Roof insulation at conference room.*
