Working To Inform

One of the larger projects scheduled for 2023 is the demolition, repair, re-design and build of the two raised planter boxes in front of Dogwood (B2.)

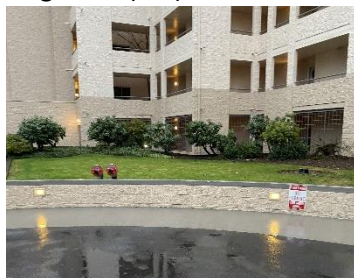
The "east" side - on your left as you approach the front door

Our 2015 Envelope Study told us these (formerly) waterproof membranes at the bottom of these concrete boxes are leaking, allowing water into and damaging the "hollow core" concrete planks that are our building foundations (and in this area, are also the garage roof.) RDH Building Sciences recommended the membranes be renewed.

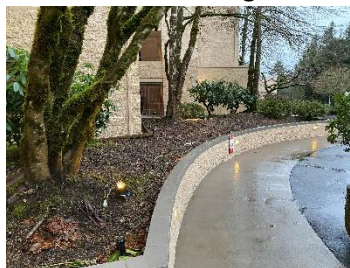
The "west" side of the Dogwood entrance - on your right as you approach the building

There are two major components to the project: The first is the deconstruction and excavation required to access and replace the thirty-five year old rubber-impregnated fabric membrane.

They've been torn by roots, ravaged by time – consequently rain and irrigation water are leaking through the membranes, into and through the building foundations and, finally,

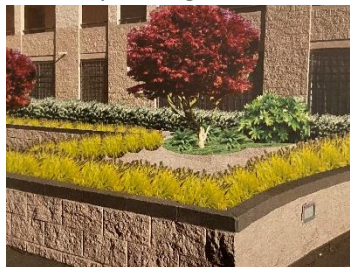
The Sequoia (B1) artist's rendering

One option is to repeat what was done at Sequoia (B1) in 2019/20 – essentially rebuild the "box" to the original 1988 design as closely as possible.

Create the box by building new retaining walls, install the necessary drains, plumbing, irrigation and electrical systems then fill the box with gravel, soil and various plantings.

Large, free-range trees are no longer allowed, though – their root systems hastened the failure of the existing membranes and clogged the drains. They are now on the naughty list.

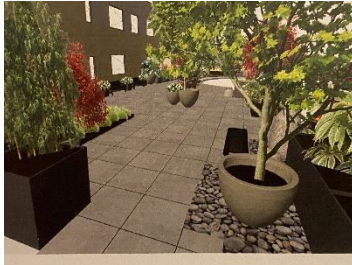
Here's an artist's rendering of the street plaza design – standing in parking spot #151 looking toward the Dogwood front doors.

Using a “pedestal-paver” system, the new waterproofing membrane atop the garage roof would be covered not with soil and rocks, but instead by a walkable surface of flat paving stones, allowing for seating areas and as many plant containers as desired.

This design has several advantages, beginning with – it's a better strategy to prevent further water intrusion into the building foundations. And, because the (locally made) concrete paver stones are slightly raised on hidden pedestals, there is room below the pavers to easily run electrical, plumbing, drainage and irrigation components – and provides much easier access to them when repair is needed.
