To Jimmy Songvilay  
Kin Living  
139 SE Taylor Street, Suite 200  
Portland OR 97214

Revised March 14, 2022 by  
RDH Building Science Inc.  
5331 SW Macadam Avenue #314  
Portland OR 97239

RDH Building Science Inc. (RDH) was retained by Kin Living to undertake an assessment of the current condition of the building enclosure of the buildings at the Quintet Condominiums complex located at 6695 W. Burnside Road, Portland, OR.

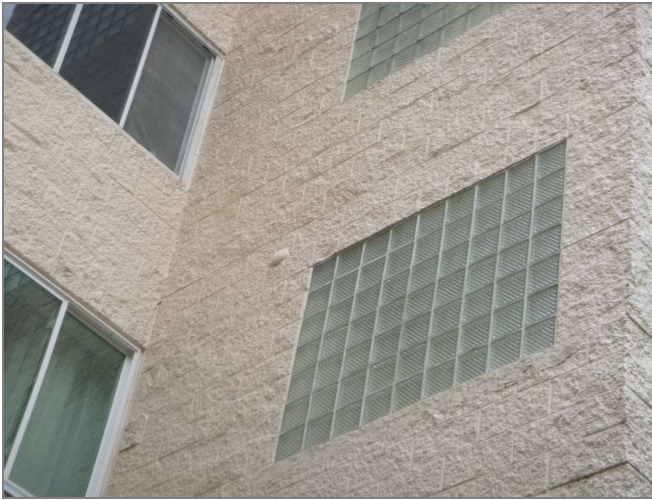
As stated in previous reports, the glass blocks are highly exposed and have no provision for movement caused by thermal expansion and contraction of the surrounding concrete. This introduces stresses in the glass and mortar joints leading to cracking and leakage. Fogging (condensation within the glass block), degradation of materials, and potential organic growth can all result from this unwanted water. Additionally, the glass blocks have little insulating value and can promote condensation on the interior surface.

*Figure 3.18  
Glass block inserts, typical*

RECOMMENDATION	
13	<i>Maintenance:</i> Continue glass block replacement program and monitor for additional and premature glass breakage or leaks.
14	<i>Improvement:</i> Consider replacing glass block areas with thermally broken windows with insulated glazing units.

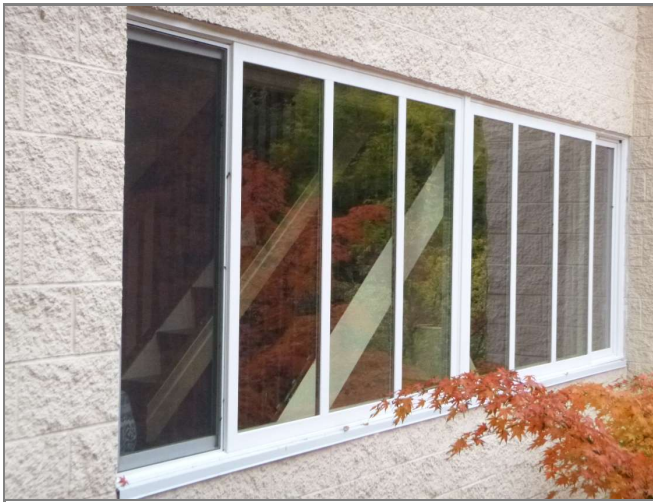
Figure 3.27  
8-pane sliding window.  
Example has been replaced  
with new vinyl-framed system.

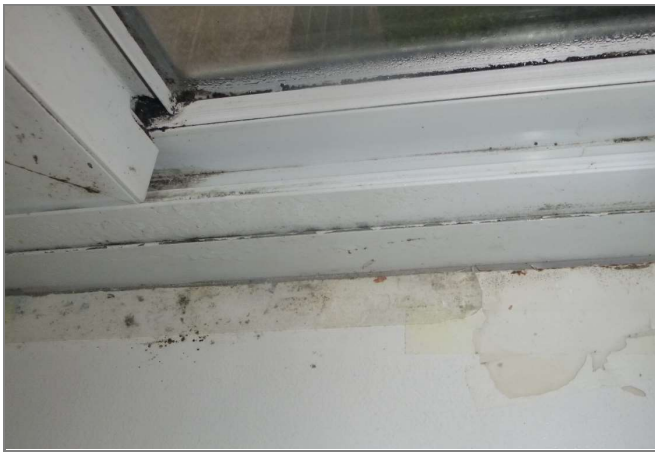
Figure 3.32

Unit 427

Condensation on interior window face and organic growth on window frame and adjacent finishes

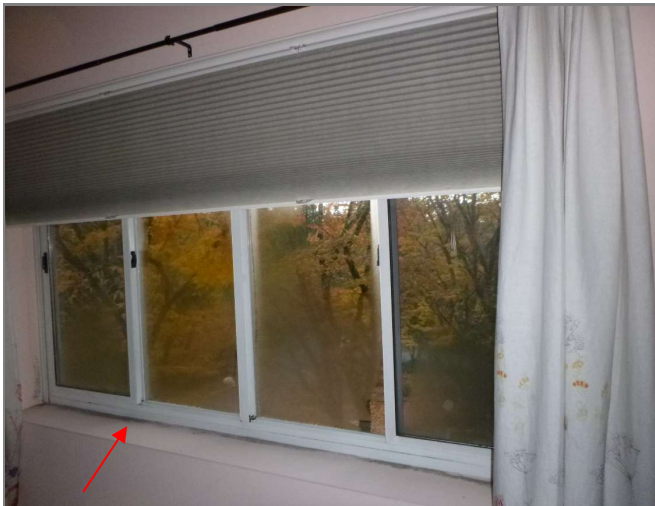
Figure 3.33

Unit 520

High levels of condensation and organic growth at interior finishes adjacent to window

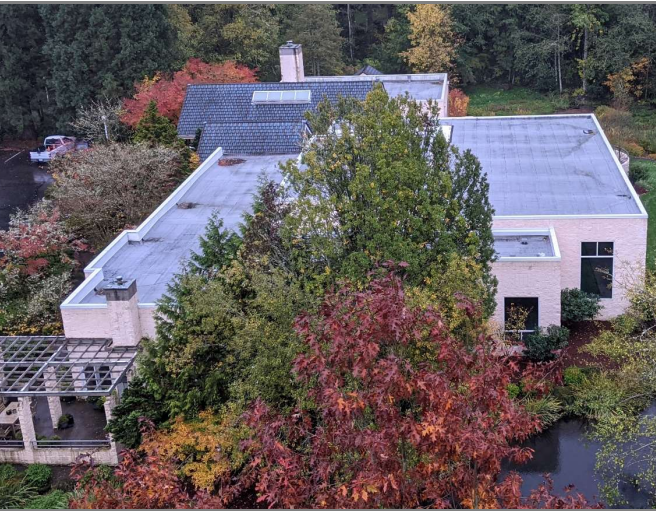
*Figure 3.94  
Clubhouse roof overview, as viewed from Building 3.*

→ The low-slope roof membrane appears to be a multi-ply modified-bitumen system with a granulated cap sheet. Discoloration is prevalent, indicating potential degranulation or debris accumulation.

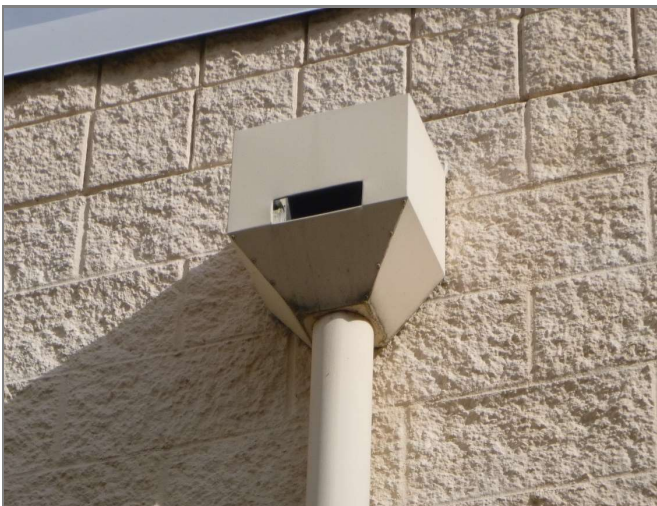
*Figure 3.98  
Clubhouse  
Typical scupper box with  
overflow.*
